# Iron River – Iron County, Michigan

## Channel Assessment Report

December 26<sup>th</sup>, 2011

Andy Selle, P.E.  
Inter-Fluve Inc  
3602 Atwood Ave  
Madison, WI

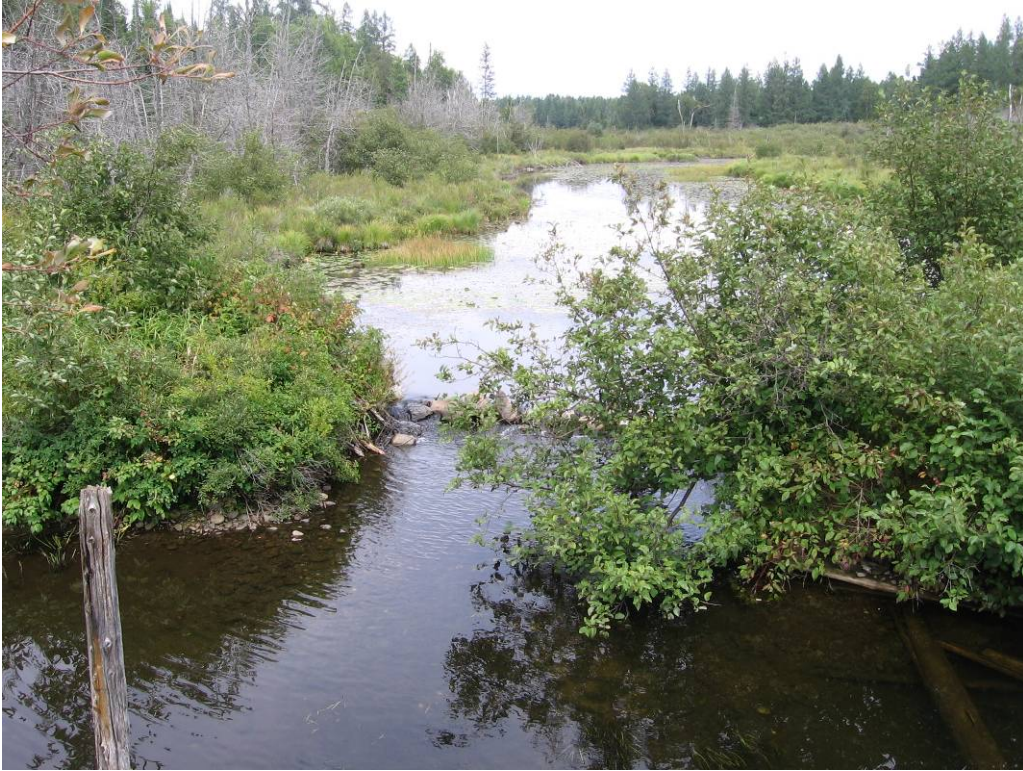
**Figure 14:** Relic water control structure upstream of AmVets Highway. The survey began below this point so elevation information was not gathered.

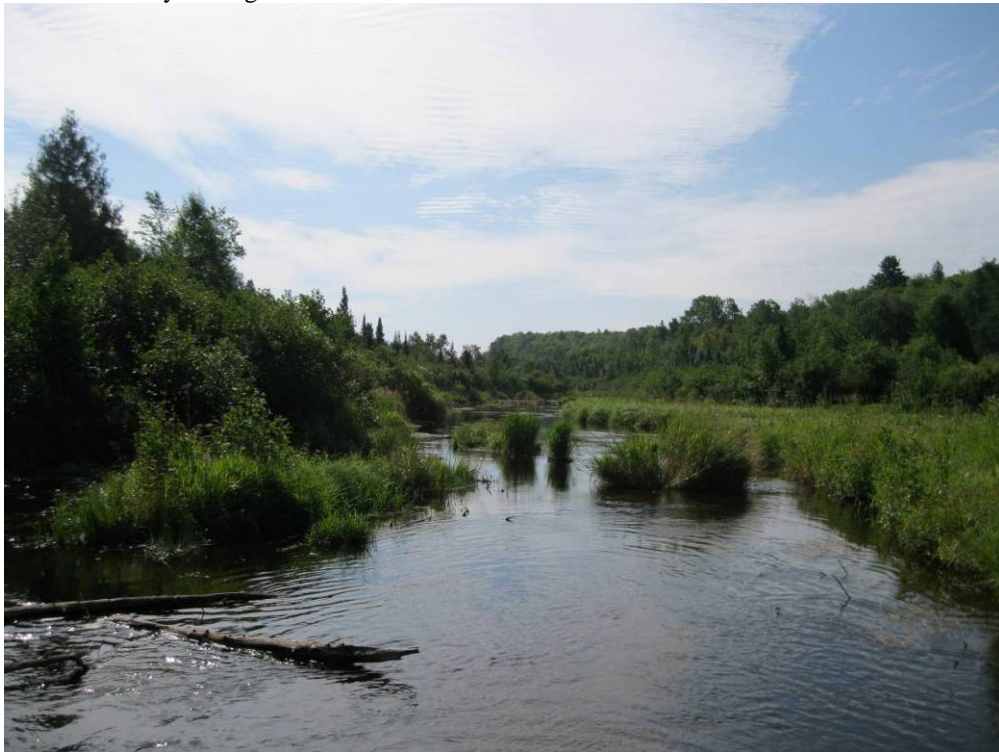
**Figure 20:** Upstream of Wild River Rd, near station 92,000, the river appears to be recovering from an impounded condition with a large volume of sediment in the river and extended valley bottom.

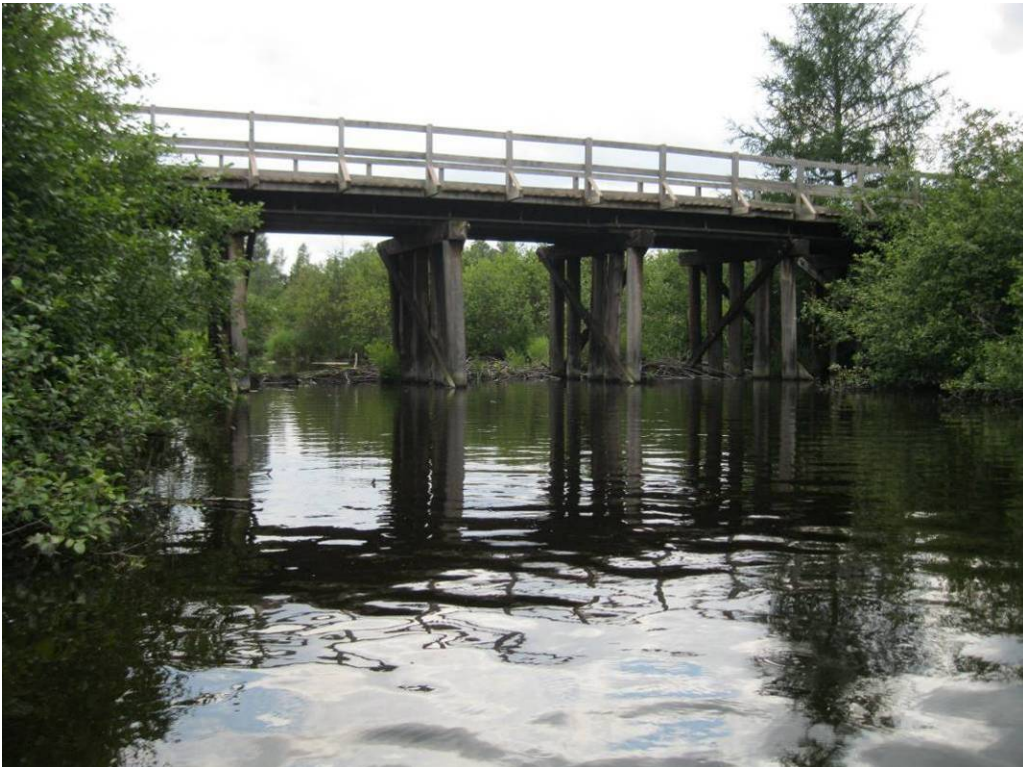
**Figure 23:** Beaver dam at ORV trail above Gibbs City Rd. This dam is controlling the water elevation up to Wild River Rd. and should be removed and maintained in a removed state.

The beaver dam at the ORV crossing upstream of Gibbs City Rd should be removed. Note, the removal of all beaver dams is not advocated, particularly in the headwaters of the Upper segment, as beavers are a natural part of this system. Beaver management should focus instead on control of the number of dams within some pre-established capacity, consistent with historic conditions. These projects should be done with an understanding that they will likely mobilize sand and fine material from upstream as the elevation controls are removed, and should be built in conjunction with sediment control measures to reduce or eliminate the downstream transport of these materials, particularly at the Gibbs City Rd crossing. Sediment traps, temporary weirs and other means are effective at this. These controls should be left in place and maintained (excavated) until upstream evacuation of sediment is complete and may require many years to accomplish.

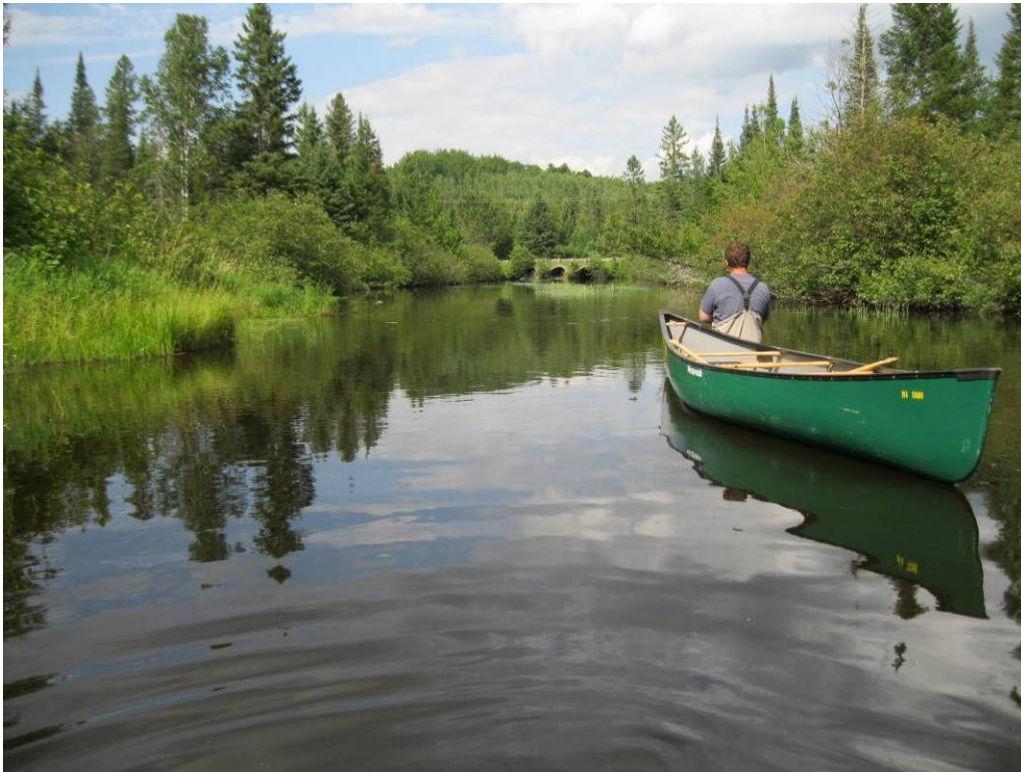
**Figure 24:** Three culverts at Gibbs City Rd. Note the slack water and presence of aquatic vegetation occupying sediment deposits in the channel.

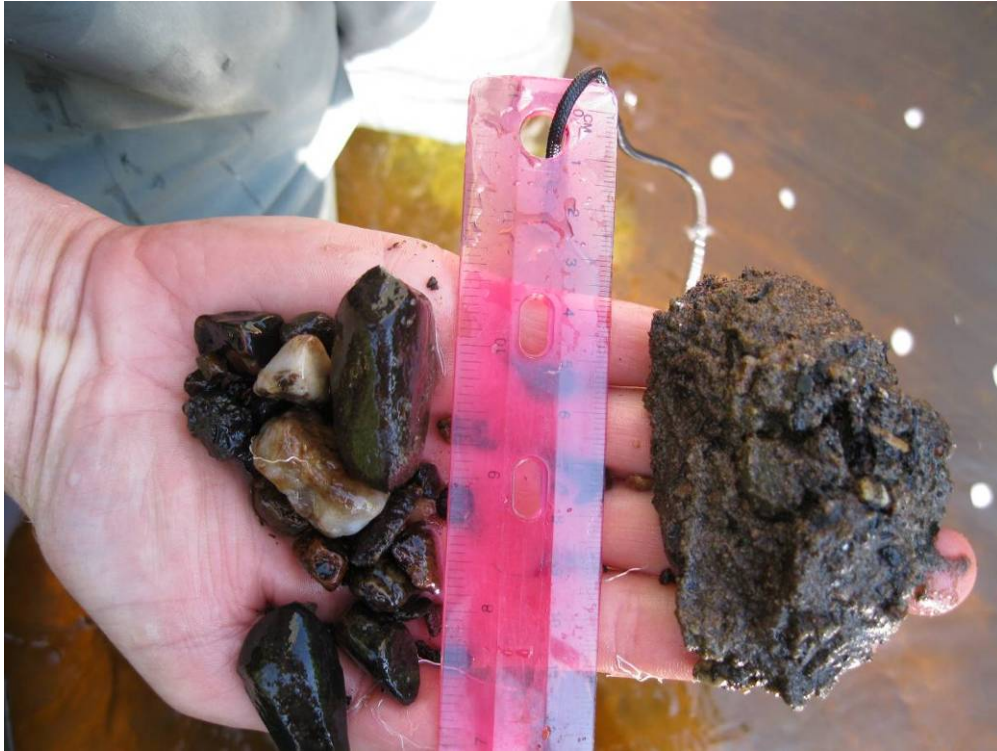
**Figure 26:** Gravel underlies sand at station 82,100 at the beginning of the transition from the steep reach above to a mild slope. Perhaps a relic deposit from Burnt Dam, a logging era structure on the river, located at station 80,790 downstream.

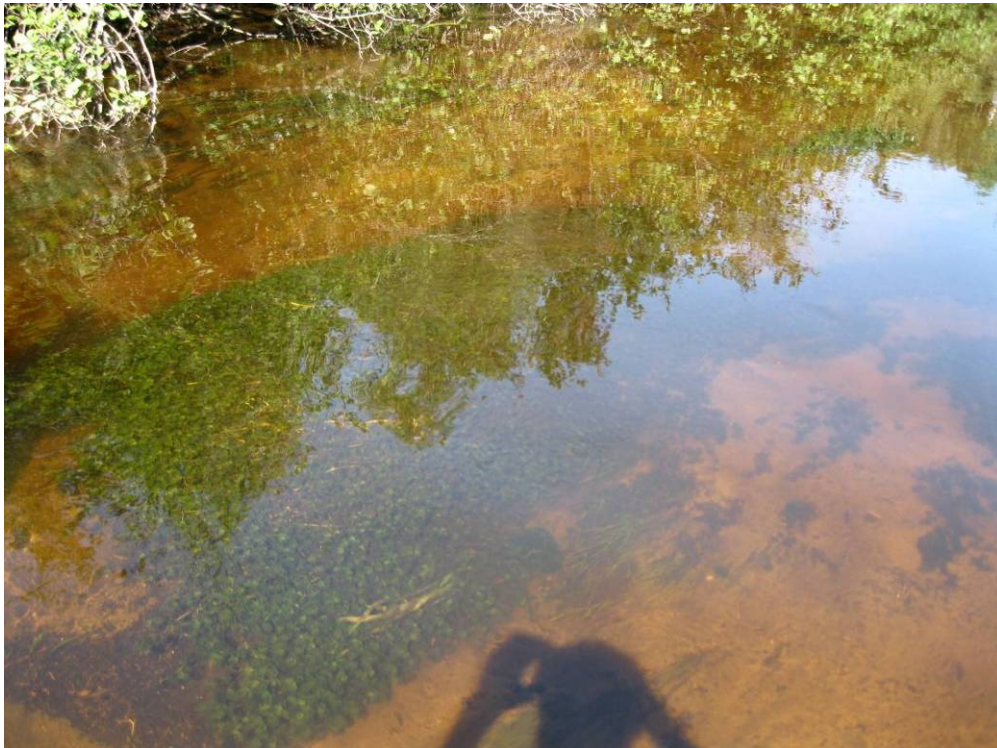
**Figure 27:** Sediment slug encountered on the river at station 79,300. Note the rooted macrophytes that add to the stability of the material and make it difficult for the river to transport. A contemporary source for this material was not apparent and it may be logging-era derived sediment.

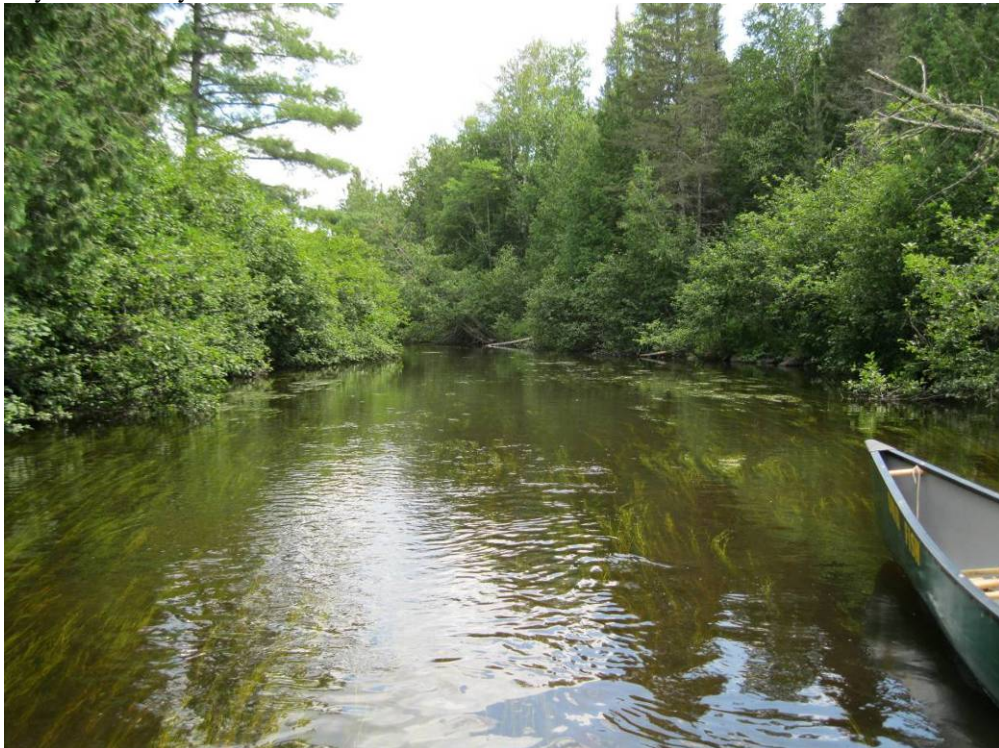
**Figure 31:** Station 66,600, here the wide section includes deposited sand which has been vegetated. In the background, note the river narrowing its width. Good habitat in this reach, though the abundance of sand and fine material may or may not be a natural feature here.

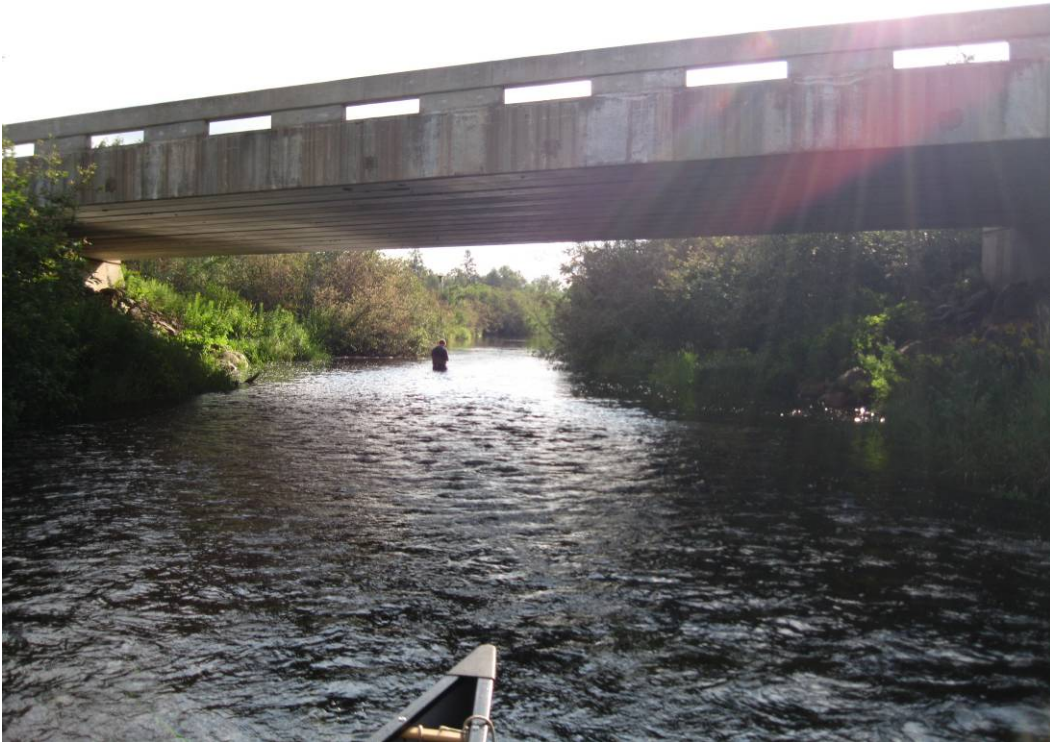
**Figure 35:** Riffle controlling elevation at 16th St bridge

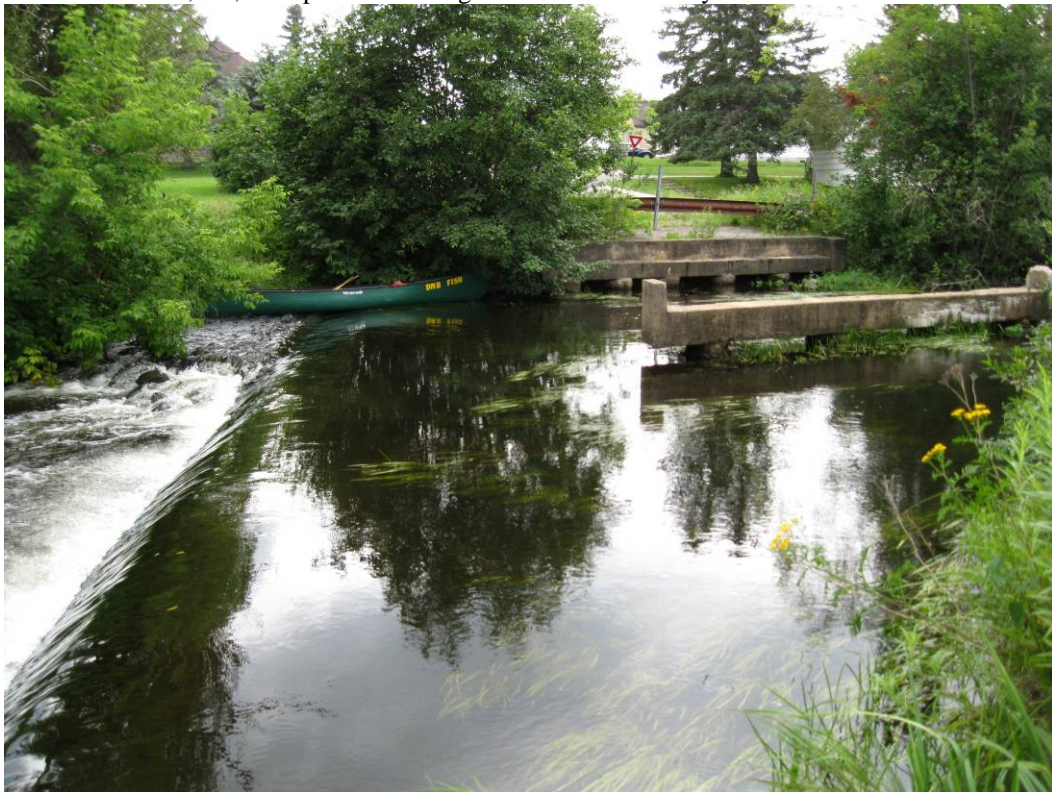
**Figure 37:** The dam at 5th Ave. A fish passage barrier it should be removed and if necessary replaced with a riffle.

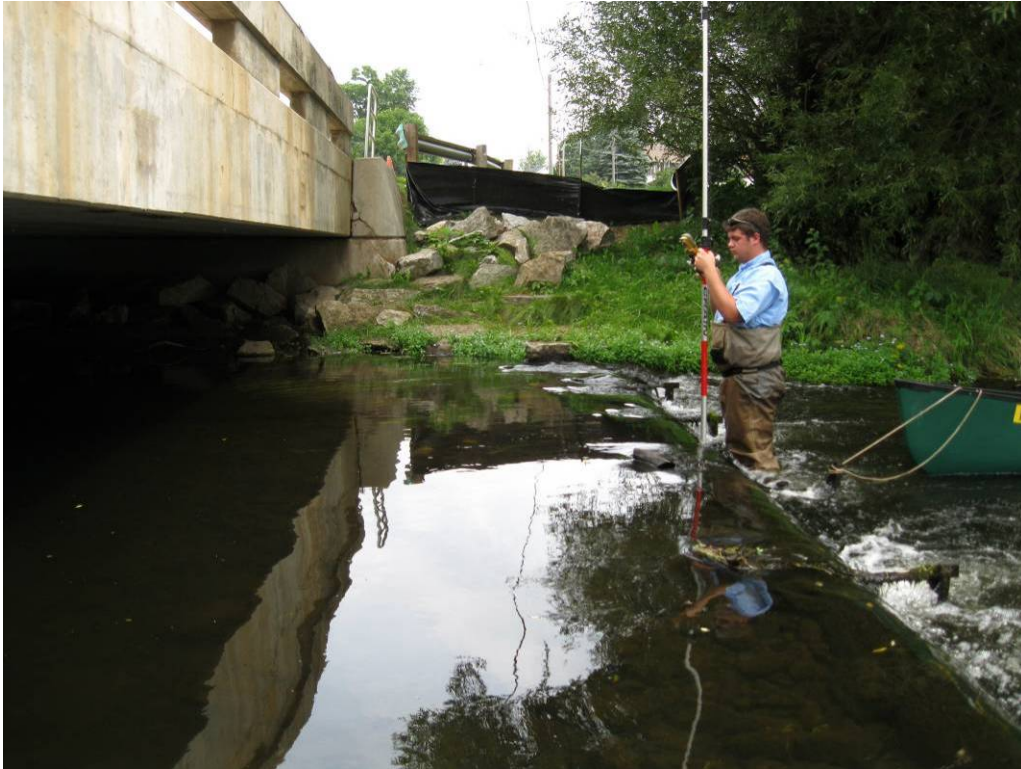
**Figure 38:** Sewer or stormwater pipe crossing at 4th Ave. This crossing is a fish barrier and should be retrofitted or removed to accommodate fish.

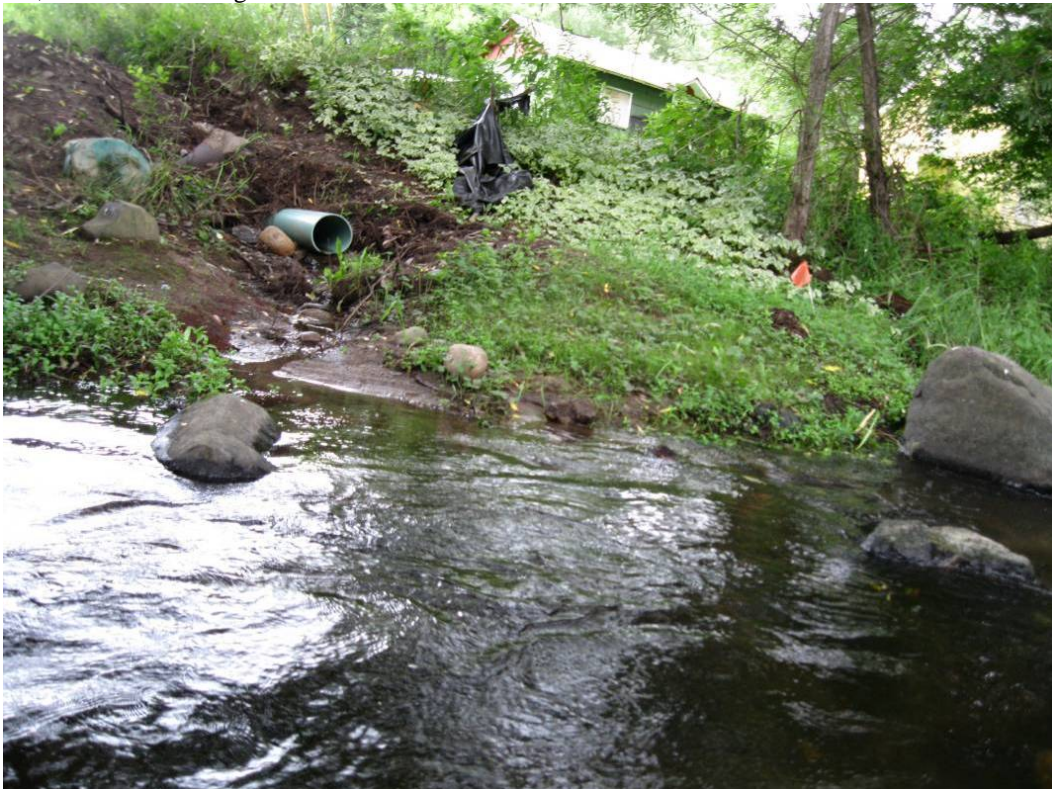
**Figure 41:** Minor stormwater issues persist in the urban section of the river, but many appear to have been remediated as well

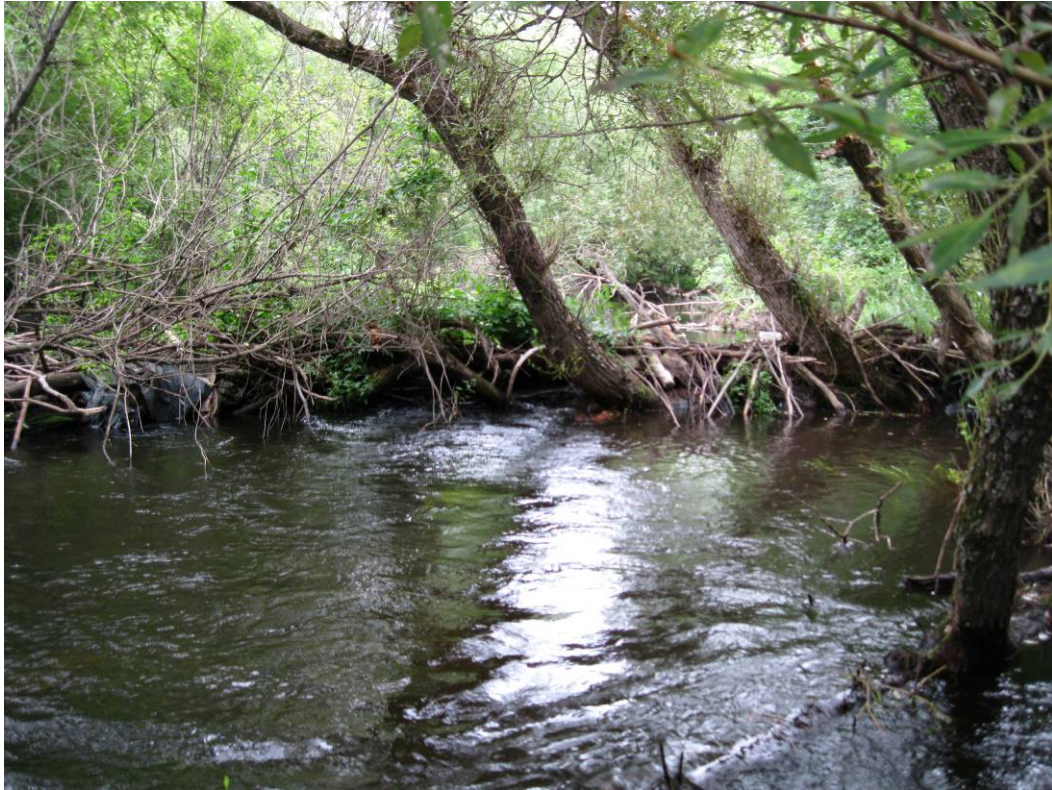
**Figure 43:** A beaver dam at station 42,500

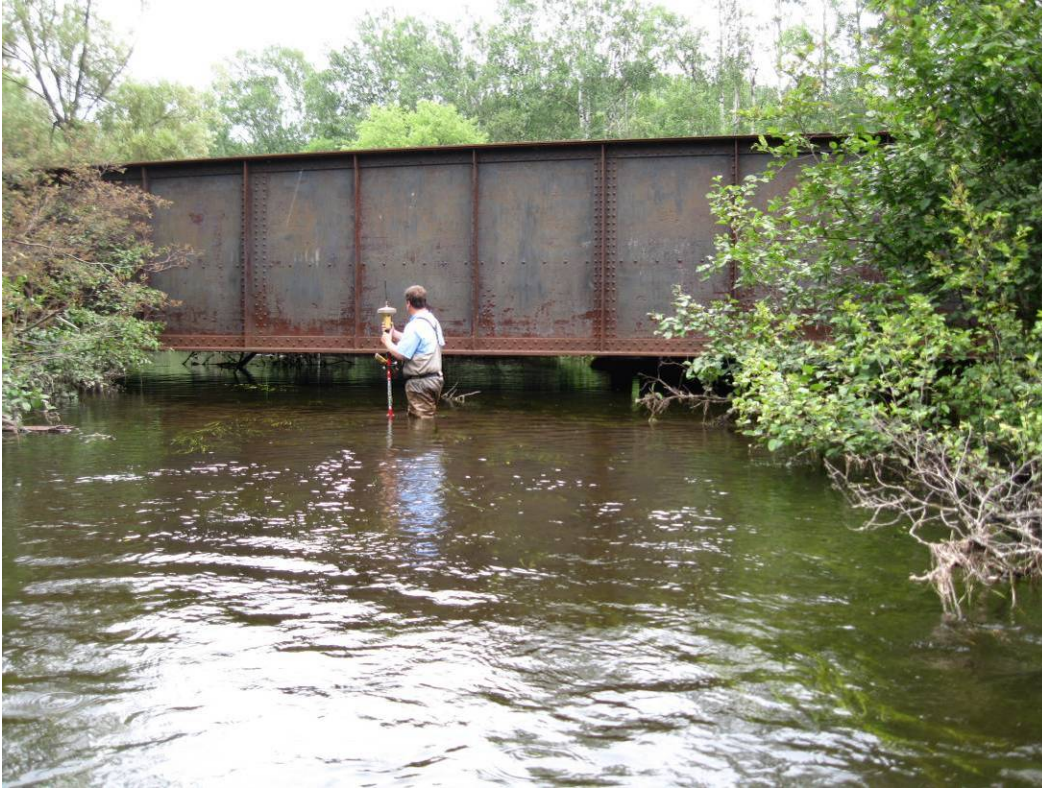
**Figure 44:** Several low bridges, relic RR crossings now used for the ORV trail are within the reach. These don't appear to have an impact at normal flows, but likely back up water during flood flows. The condition of these bridges indicates they are near the end of their design life. Replacement structures should be built within a restoration context of the reach and ensure little impact on river transport and fish passage.

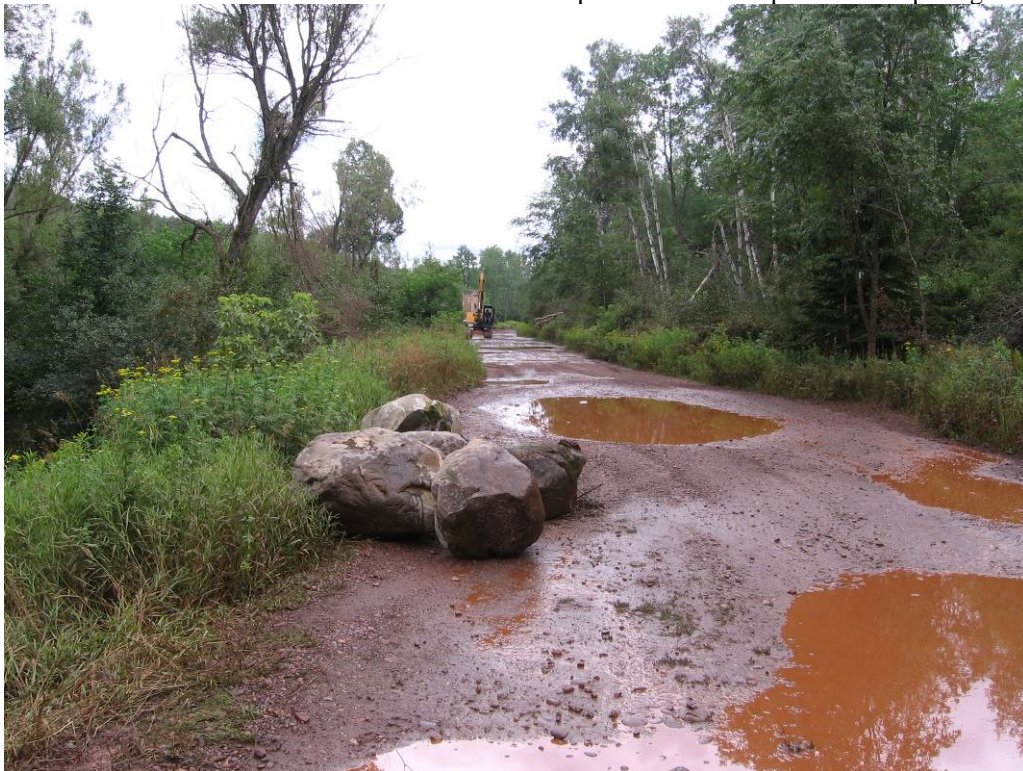
**Figure 45:** Runoff from the ORV trail contributes suspended sediment to the adjacent river

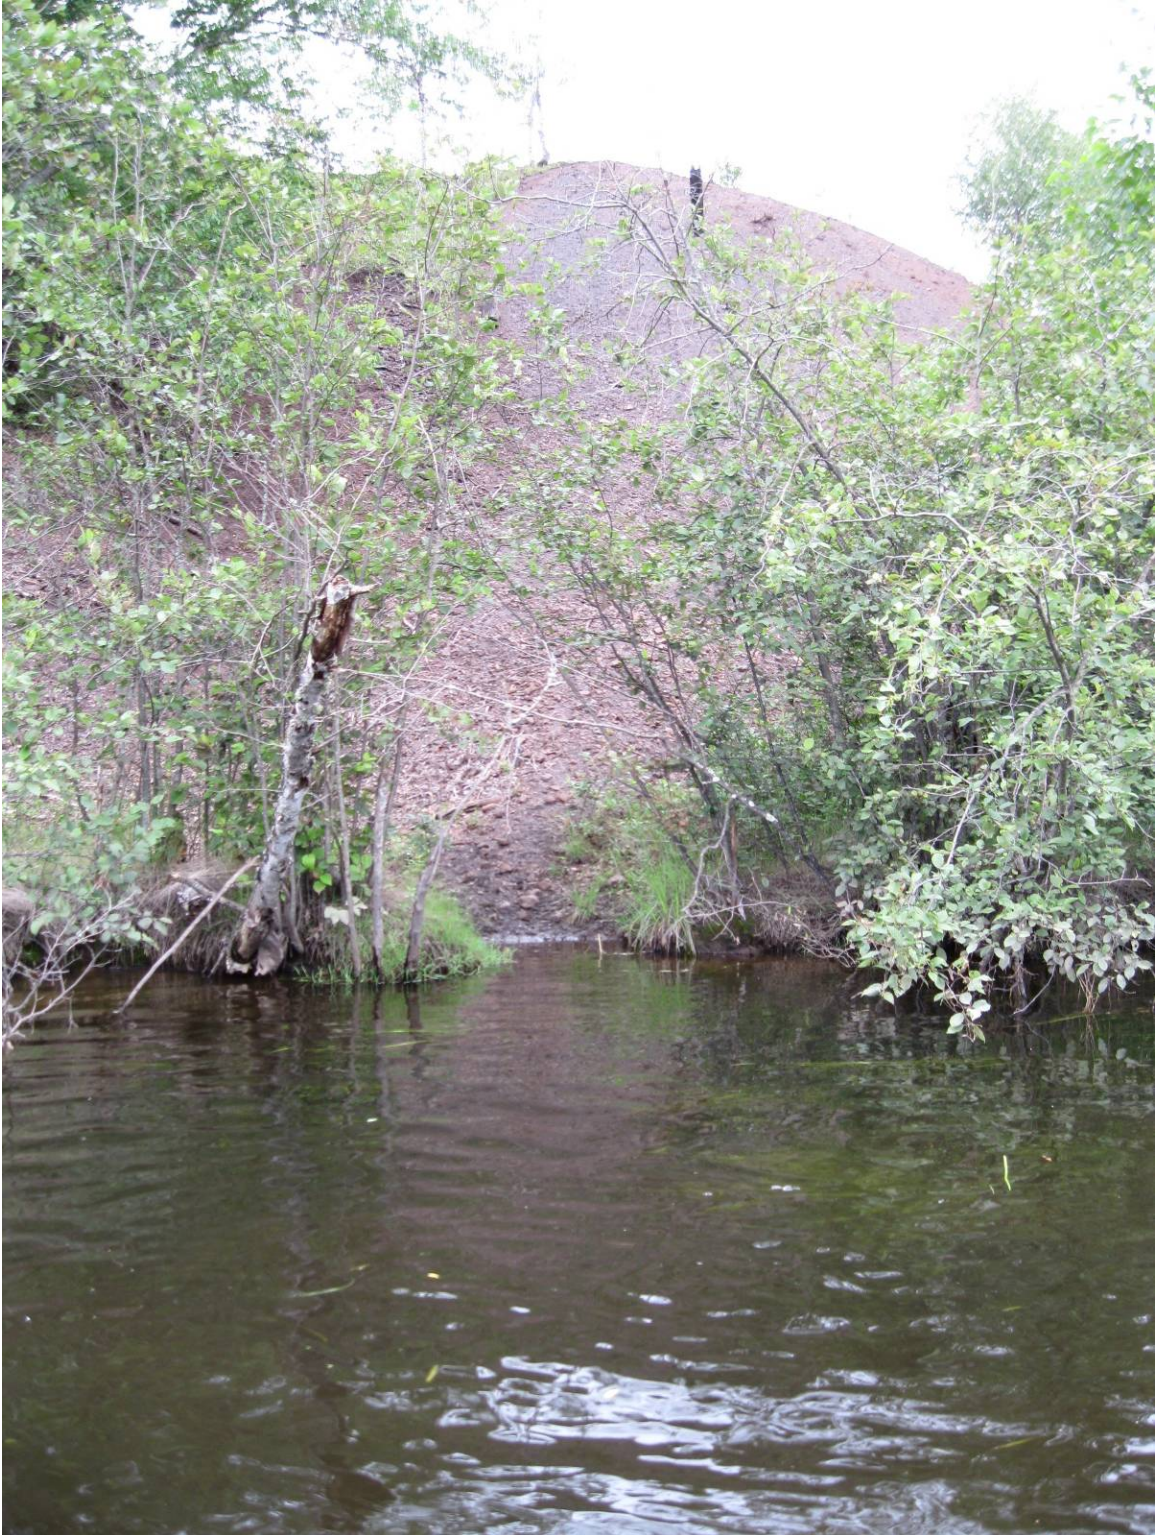
Station 42,000 marks the beginning of historic mining impacts that, although addressed in part, continue to impact the river channel downstream to station 36,000. The riparian area in this reach is largely gone, replaced by a monoculture of alder. The ORV trail is paved in mine tailings or a similar product and contributes a heavy red suspended sediment to the river when it rains. Tailings piles are still present within the river valley and the banks of the river are composed of mine waste in many locations. The channel has been straightened significantly through most of the reach as well. Some remediation work has been done and the dam at station 37,700 is part of a plan to maintain a stable water surface elevation upstream to provide mitigation for mine waste. The dam has a fish ladder included on the right side of the river but it appears to be inoperable and its efficacy at passing fish is suspect. The dam acts as both a fish and sediment barrier and should be removed and replaced with a series of riffles that maintain water elevations required by the upstream project. Overall this stretch of just over a mile should be completely restored, including remeandering, the planting and preservation of a native riparian area, BMPs constructed to eliminate runoff from the ORV trail etc. This is a significant undertaking within the context of what appear to be contaminated soils throughout the project area.

**Figure 46:** Mine tailings are still prominent features within the river corridor

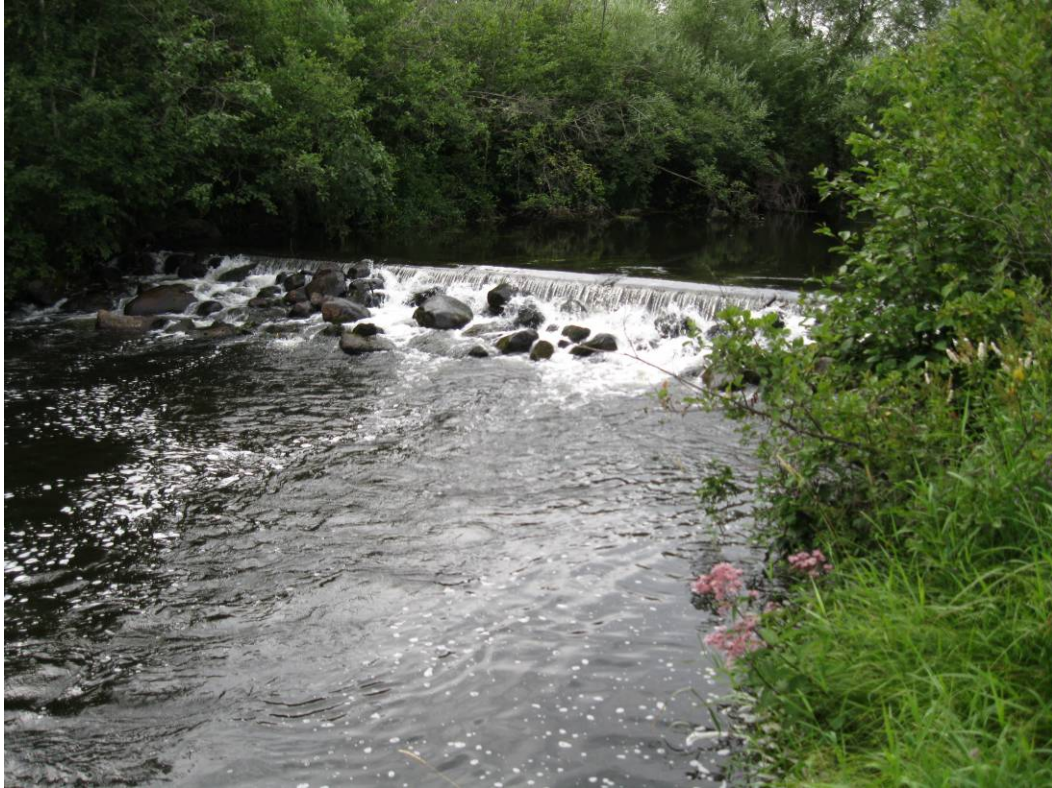
**Figure 47:** The dam at station 37,700 is blocking fish passage but is an integral part of a wetland remediation project upstream. The dam should be removed and could be replaced with a series of riffles to accomplish the same purpose and improve habitat.

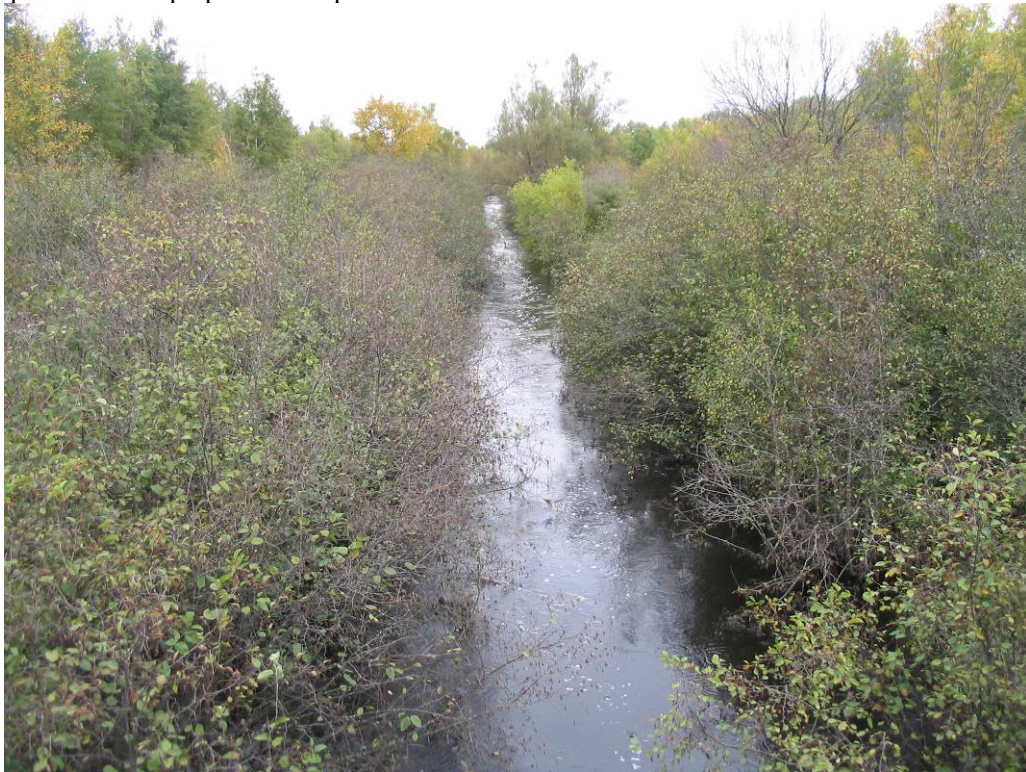
**Figure 48:** Straightened condition of the river through the mining impact area.

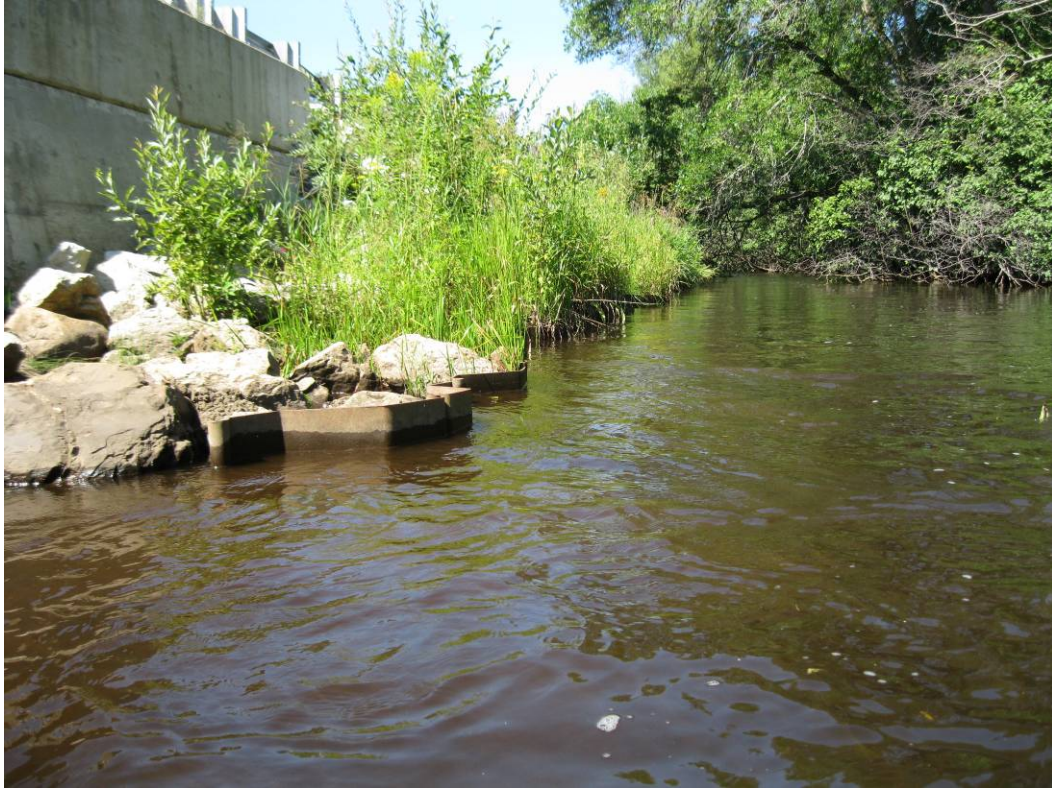
**Figure 49:** Brady Ave crossing, showing some armoring of the stream bank with sheet pile.

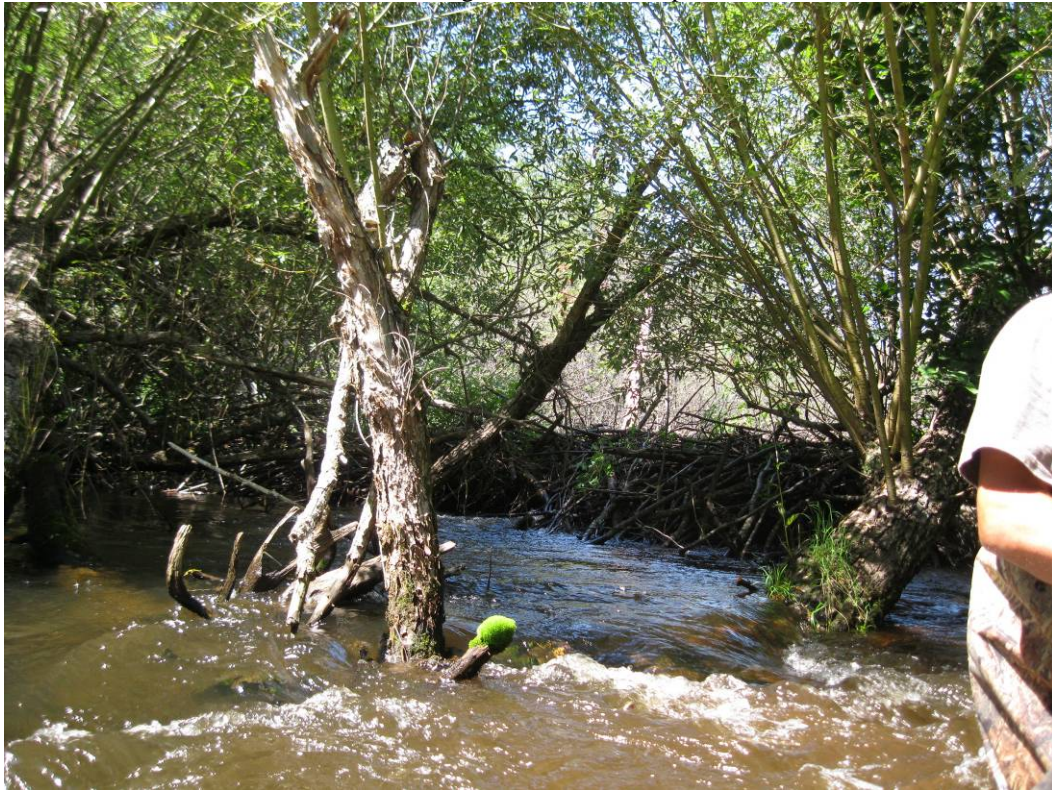
**Figure 52:** large beaver dam at station 24,500, impounding water behind. Fish passage at these structures is unknown, but beavers are a natural part of the system and these are temporary obstructions.
