PROJECT REPORT
Project Number 08-02

**Evaluating the Effects of a Dam Removal on the
Morphology, Habitat, Aquatic Invertebrates, and
Temperature, of the Iron River (Iron County, Michigan)**

Date: March 24, 2009

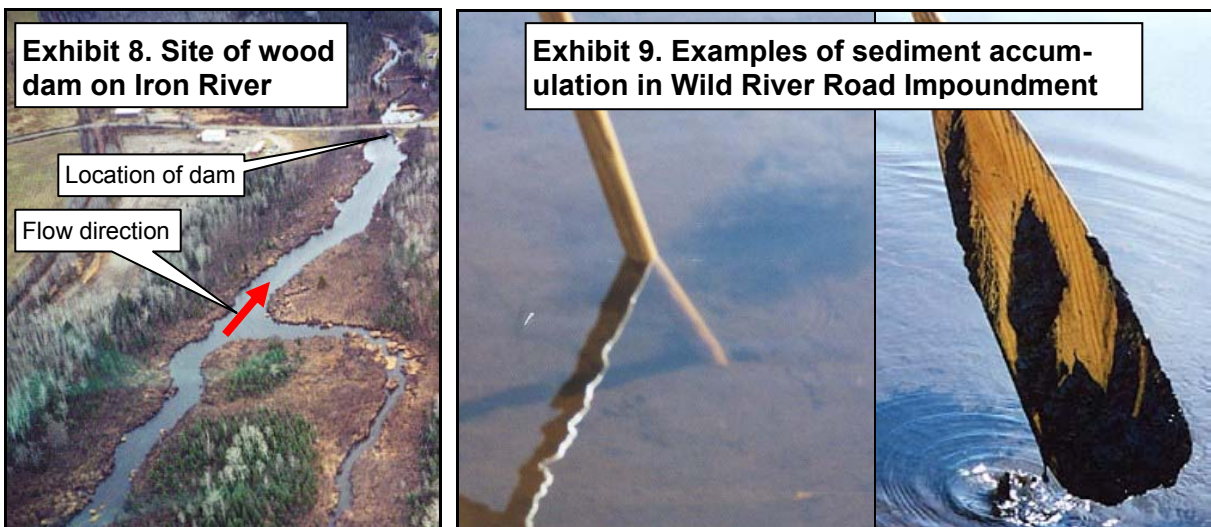
Exhibit 8 shows a low-level aerial photograph of the site a couple of years prior to the removal of the wood dam. This photo is looking southeast (downstream). The location of the dam (at upstream end of culvert on Wild River Road) is indicated on the photo. In the foreground left on Exhibit 8 is the North Branch of the Iron River. Coming in from the right is the South Branch of the Iron River. The zone of influence of the dam extends a bit upstream of the coverage of this photo. As can be seen, a large pool exists immediately below Wild River Road and below this point the Iron River takes on its more typical width. This pool below Wild River Road is typical of those seen below pine logging dams where cascading pine logs and heavy flow during the river drives tended to scour out deep pools. Over the years organic sediment and other fine materials collected in the impounded area upstream of the dam. Exhibit 9 shows a canoe paddle (in 2000) pushed into the sediment beyond the blade and the thick sticky sediment on the blade after it was withdrawn.

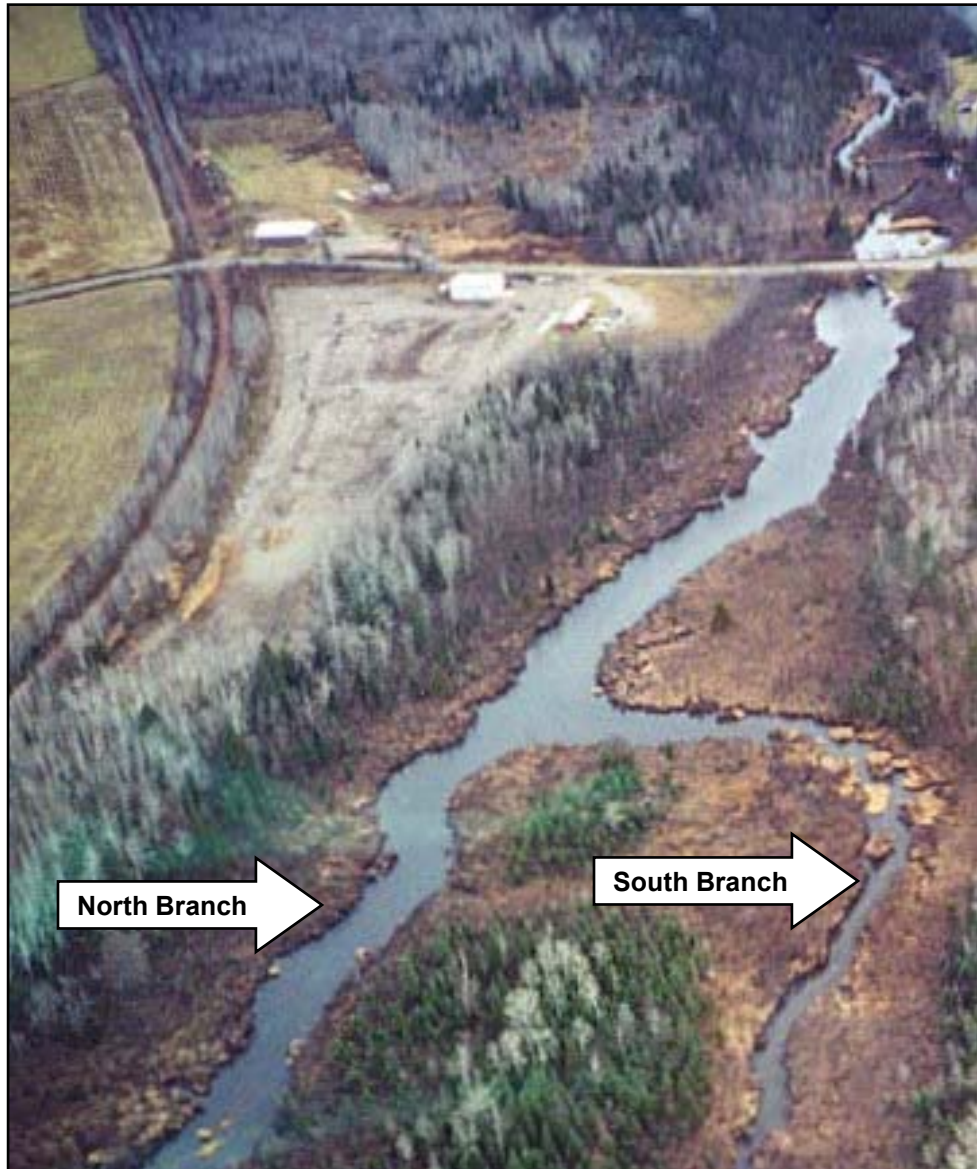
Photo 1. Low-level aerial photograph of the impounded area of the Iron River (looking southeast or downstream). (Photo taken approximately in 2000, before dam removal)

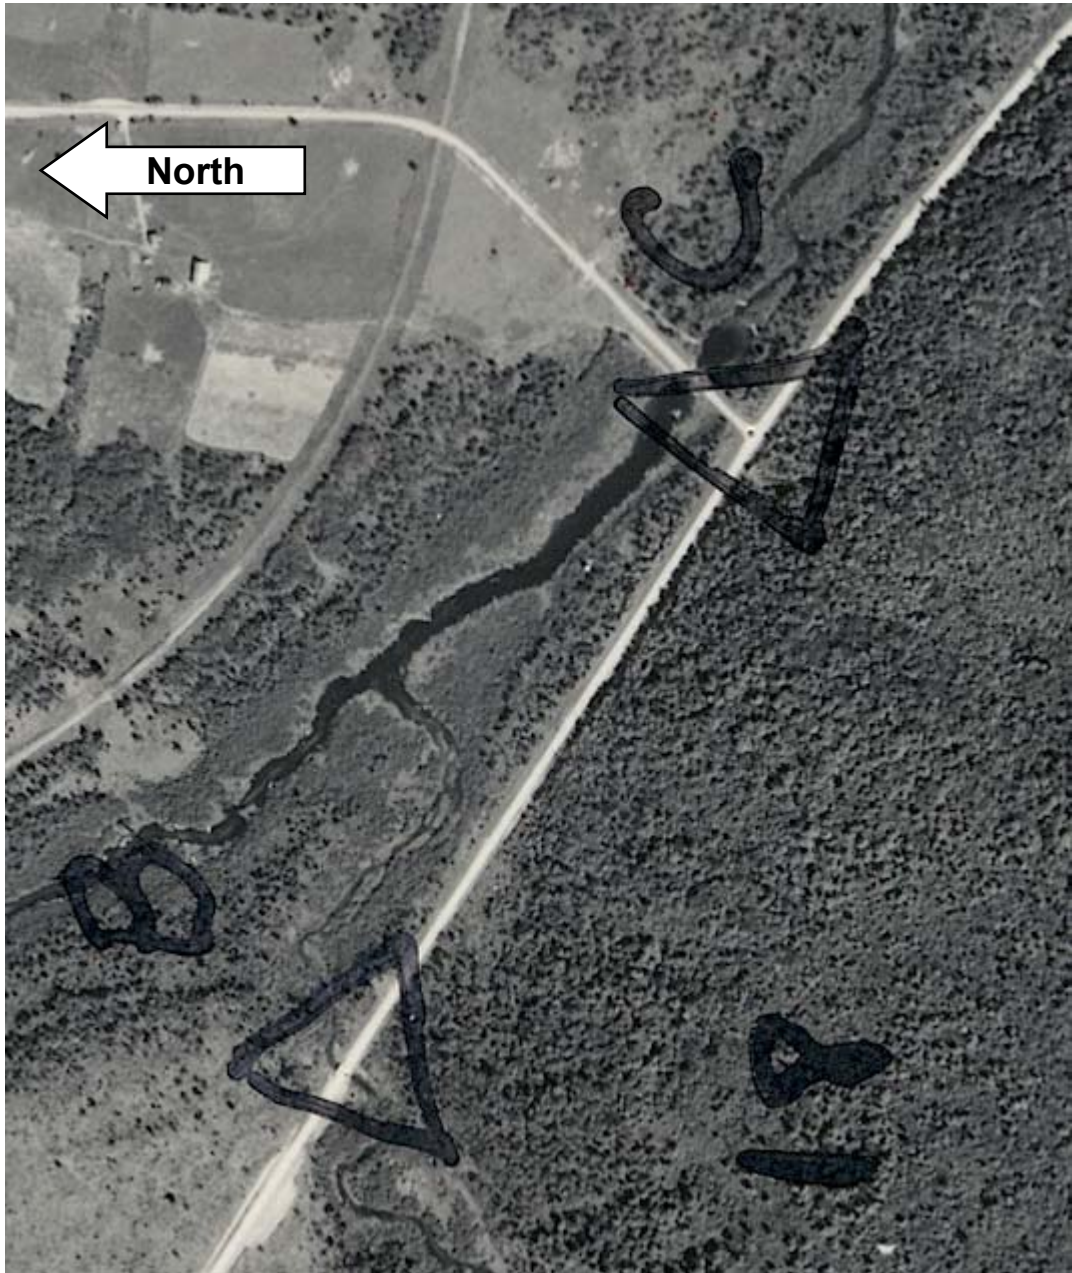
Photo 3. Aerial photograph (1983) of the impounded area of the Iron River prior to dam removal (River flow direction is from lower left to upper right) (Source: Michigan State University, Aerial Archive Office).

Photos 2-6 are an historical series of aerial photos of the impounded area prior to dam removal. In these photos, river flow is from the lower left to the upper right. In the photos, north direction points to the left. The North Branch of the Iron River enters the photographs from the northwest; the South Branch of the Iron River enters the photos from the west. The old impoundment appears full in these photos with little change apparent in the gross morphology of the river and impoundment from 1939 through 2005. The influence of the dam up into the North and South Branches of the Iron River can be seen. This upstream influence is more dramatic when compared with Photo 7, the same view and scale as the previous photo, but clearly post dam removal (source: Google Maps). The river is narrower and small island features have emerged. The width of the South Branch of the Iron River has greatly diminished. Apparent shallower water and green aquatic vegetation can be seen in the old impoundment (Photo 7).

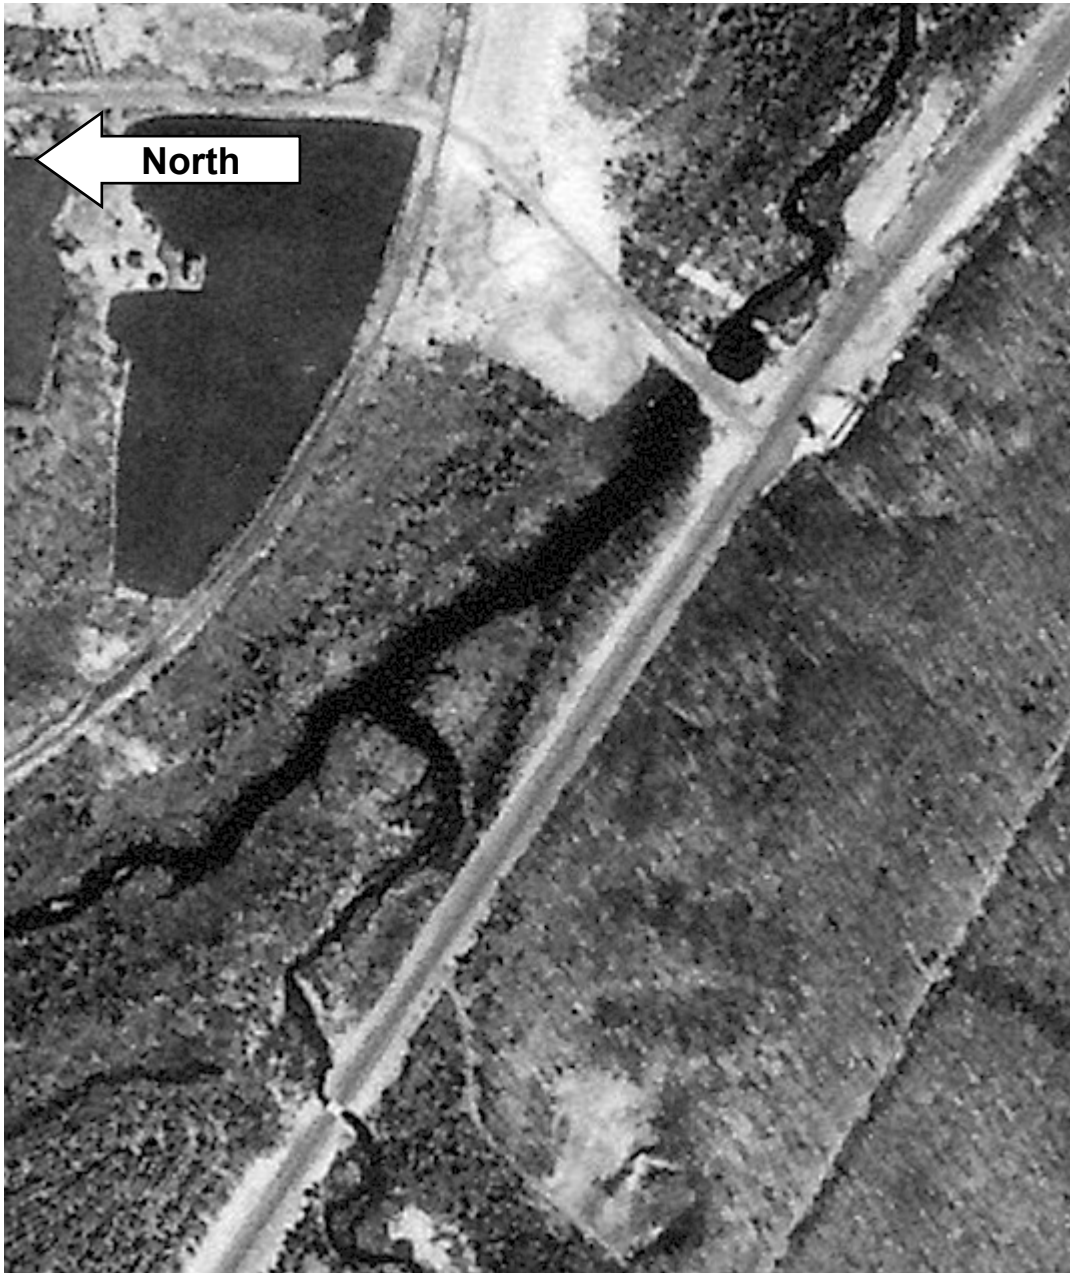
Photo 4. Aerial photograph (1992) of the impounded area of the Iron River prior to dam removal (River flow direction is from lower left to upper right) (Source: Michigan Geographic Data Library).

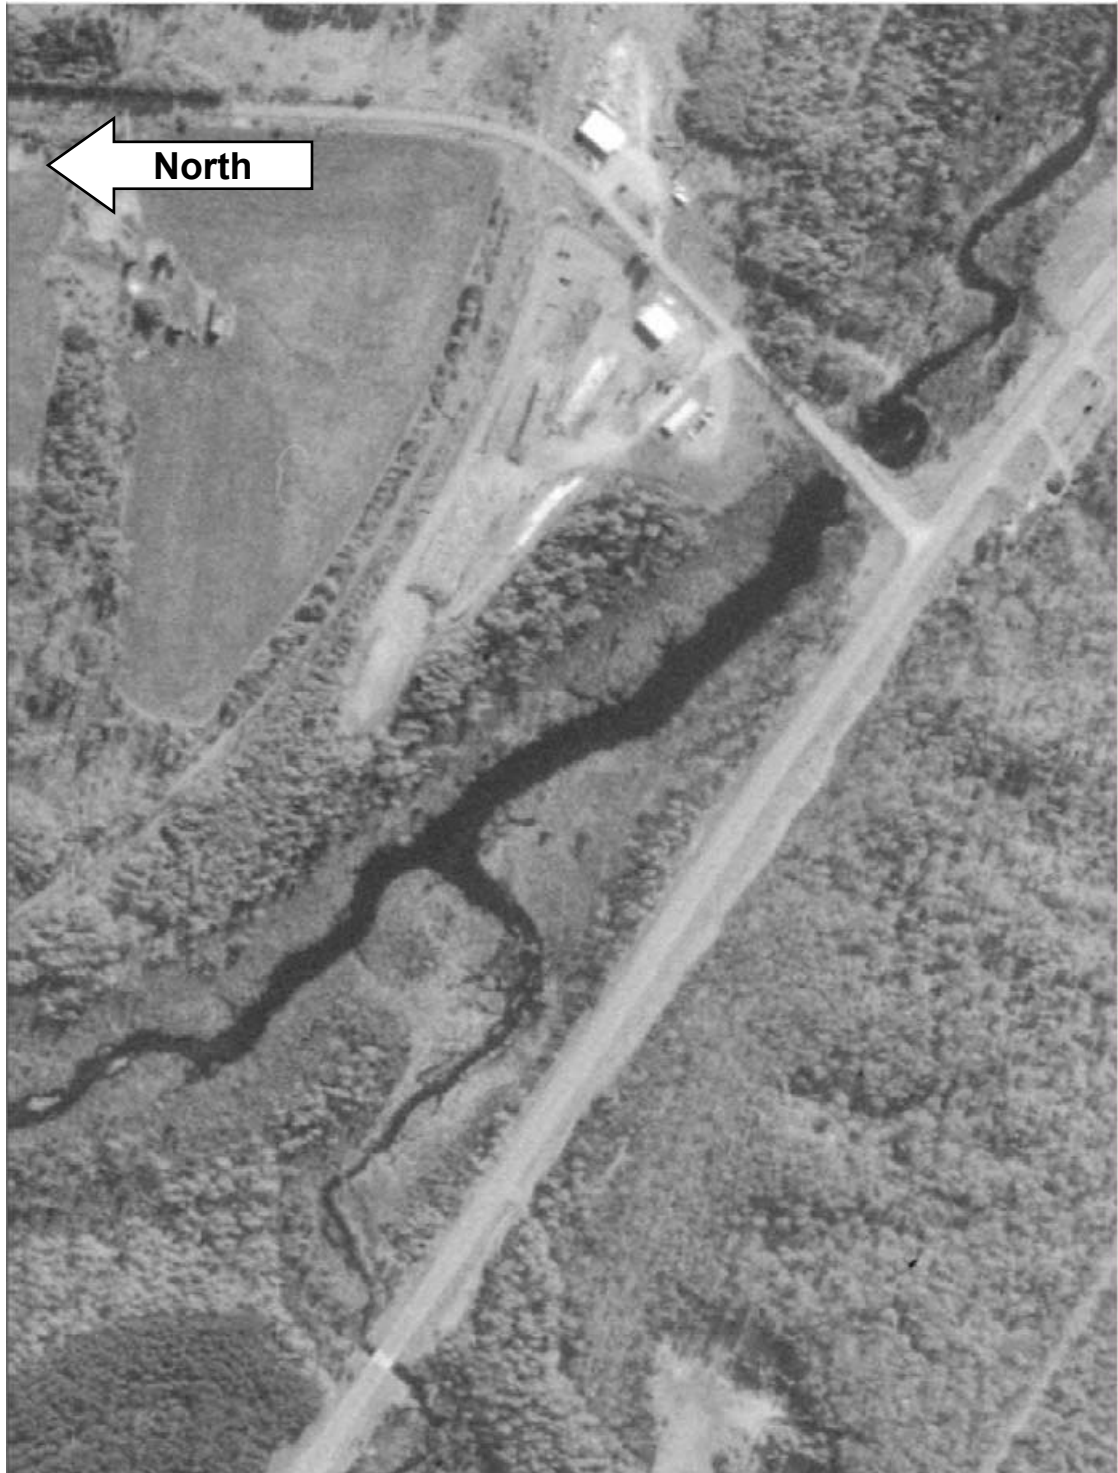
Photo 5. Aerial photograph (1998) of the impounded area of the Iron River prior to dam removal. (River flow direction is from lower left to upper right) (Source: Michigan Geographic Data Library).

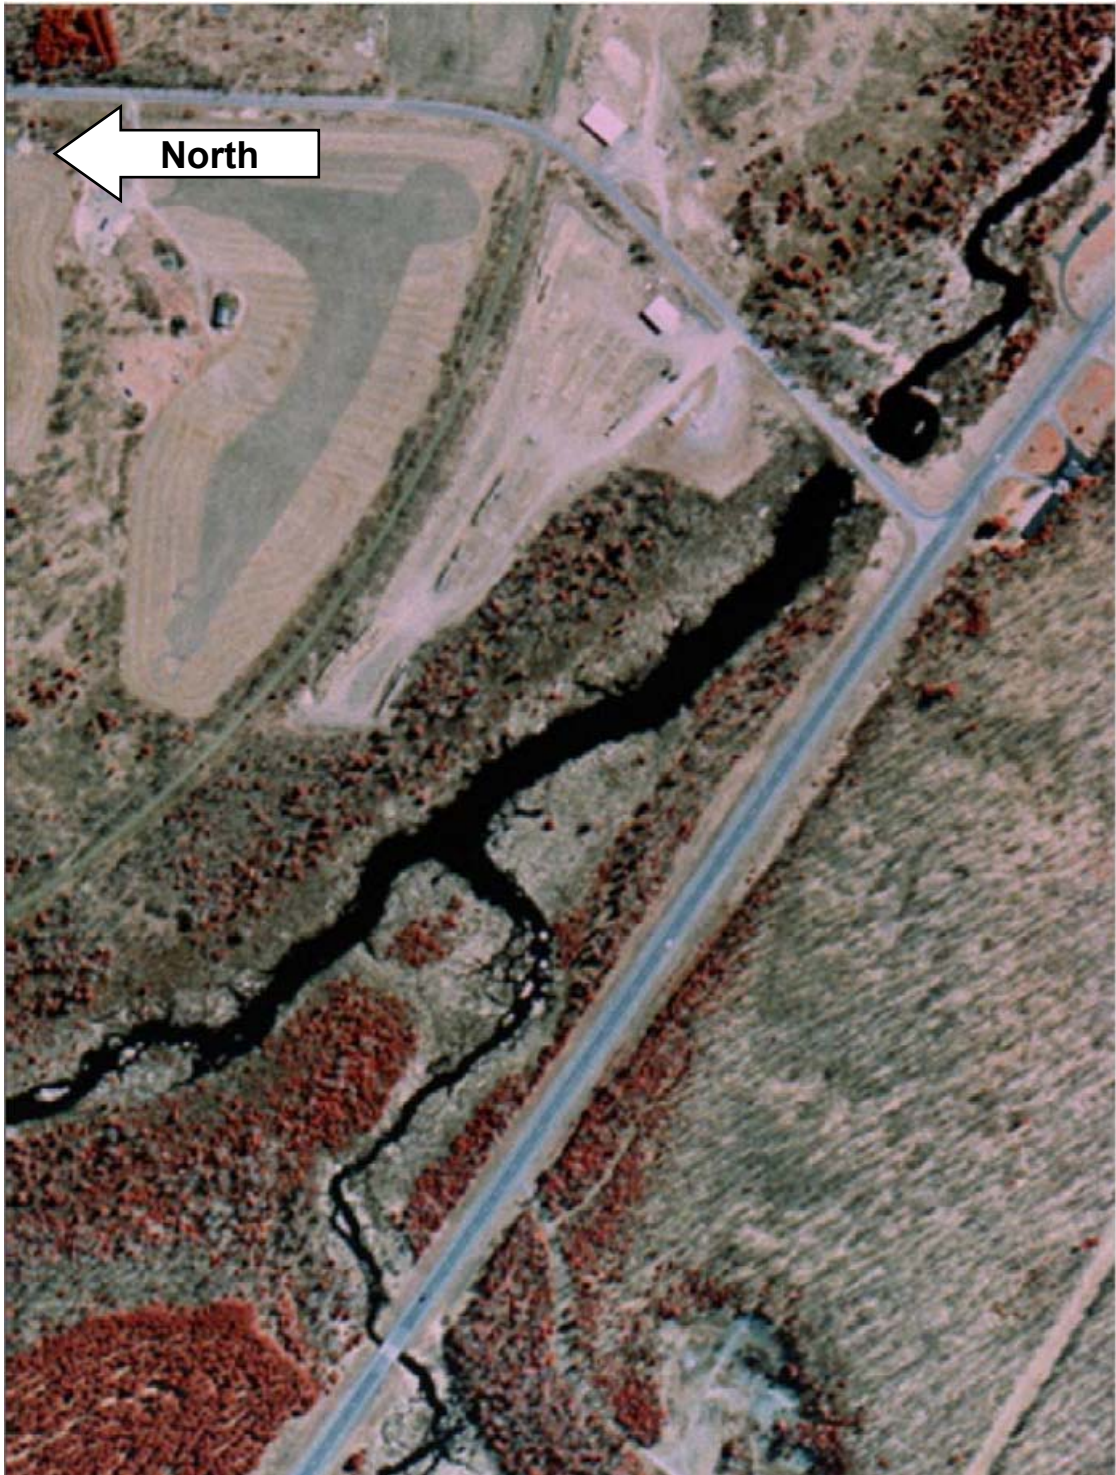
Photo 6. Aerial photograph (2005) of impounded area of the Iron River taken prior to dam removal. (River flow direction from lower left to upper right) (Source: Michigan Geographic Data Library)

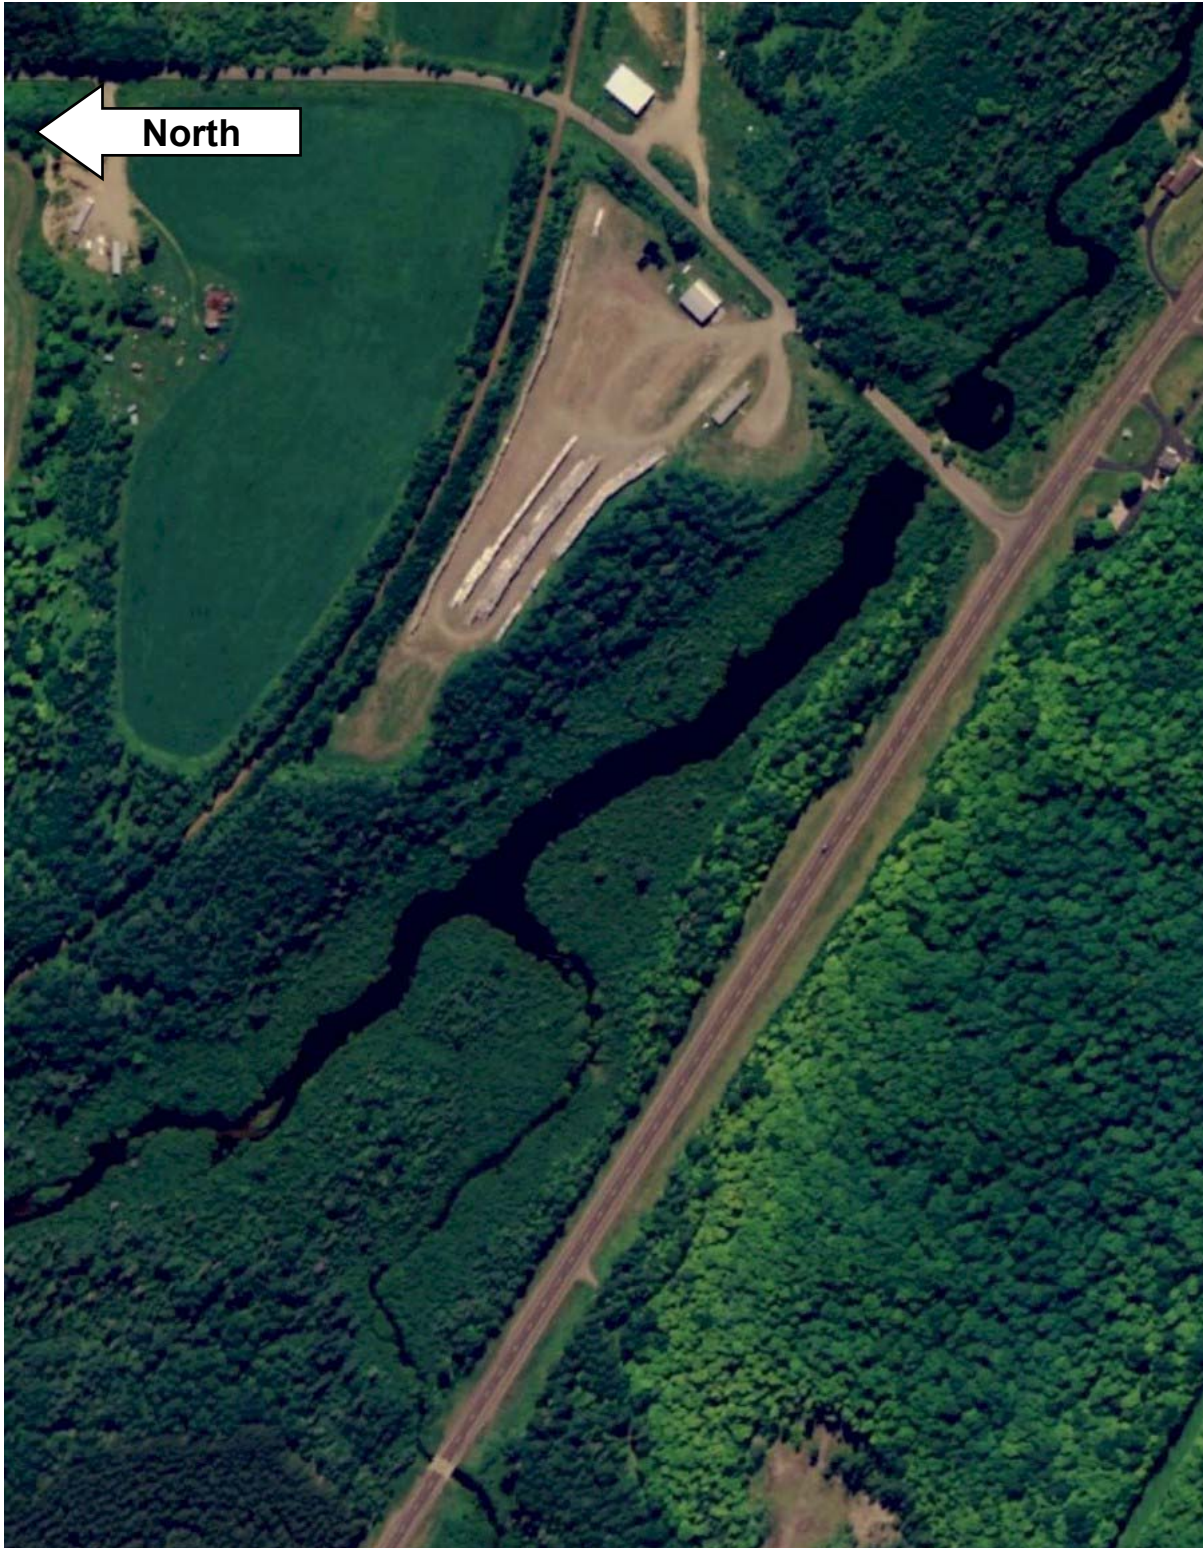
Photo 7. Aerial photograph of the impounded area of the Iron River after dam removal. (River flow direction from lower left to upper right)
(Source: Google Maps)

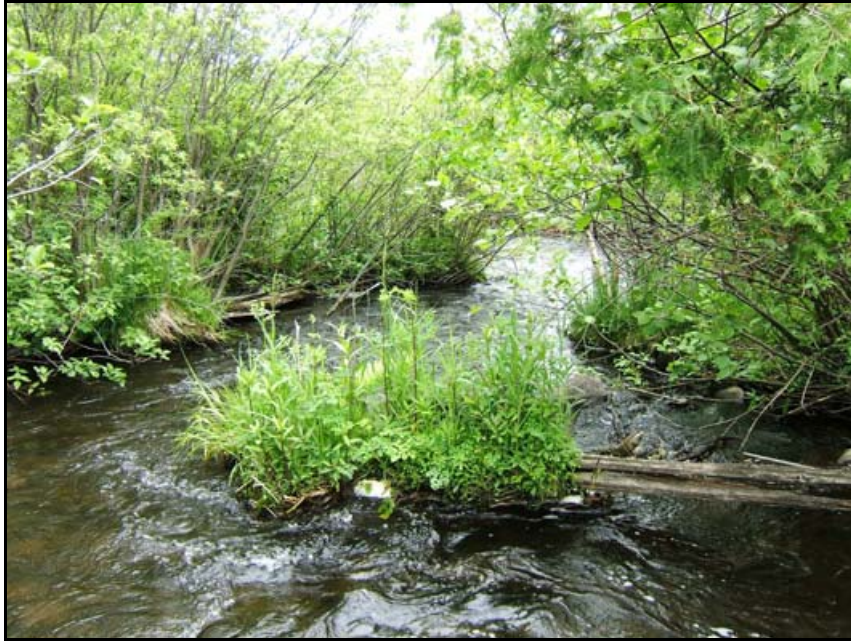
The South Branch Iron River at the US-2 crossing (Photo 8) had the highest habitat rating (188 of 220) with near perfect scores for most habitat metrics. The variety of hard substrates (boulder, cobble, gravel, and woody debris) and flows allow for full macroinvertebrate

Photo 8. South Branch Iron River within the macroinvertebrate sampling reach.
(Looking downstream)

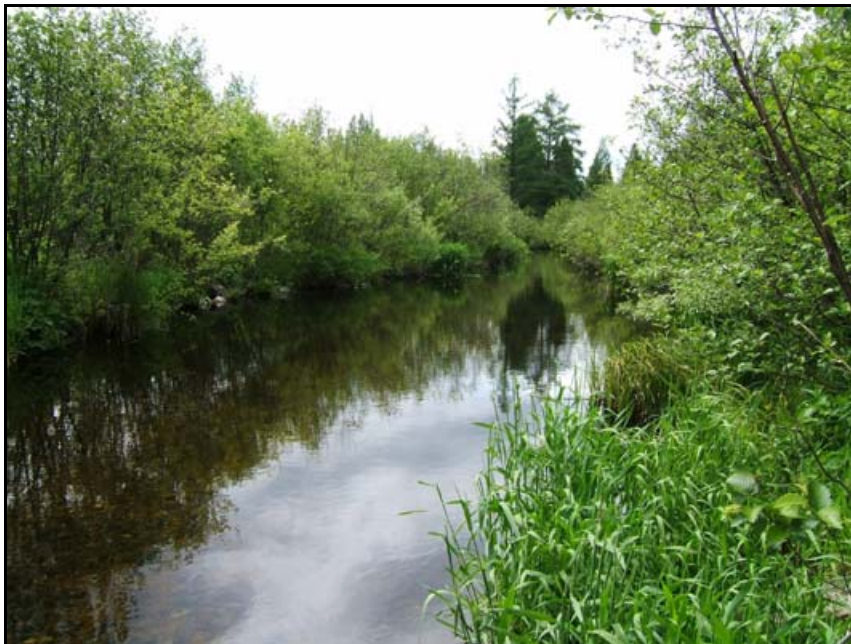
The North Br. of the Iron River at the pipeline crossing (Photo 9) had a habitat rating of “excellent” (total score of 168). This section was comprised primarily of a Pool/Glide stream type that was rather uniform in depth and flow velocity. The area upstream of the pipeline crossing may have been modified in the past as it appeared to be straightened. A great variety of macroinvertebrate taxa (42 types) were collected at this station including large numbers of physid snails, water boatmen, midges, burrowing mayflies, brachycentrid and limnephilid caddisflies. Most of these taxa are associated with fine gravel and sand, plant beds or stream edge areas.

Photo 9. North Branch Iron River within the macroinvertebrate sampling reach.
(Looking upstream from the pipeline crossing)

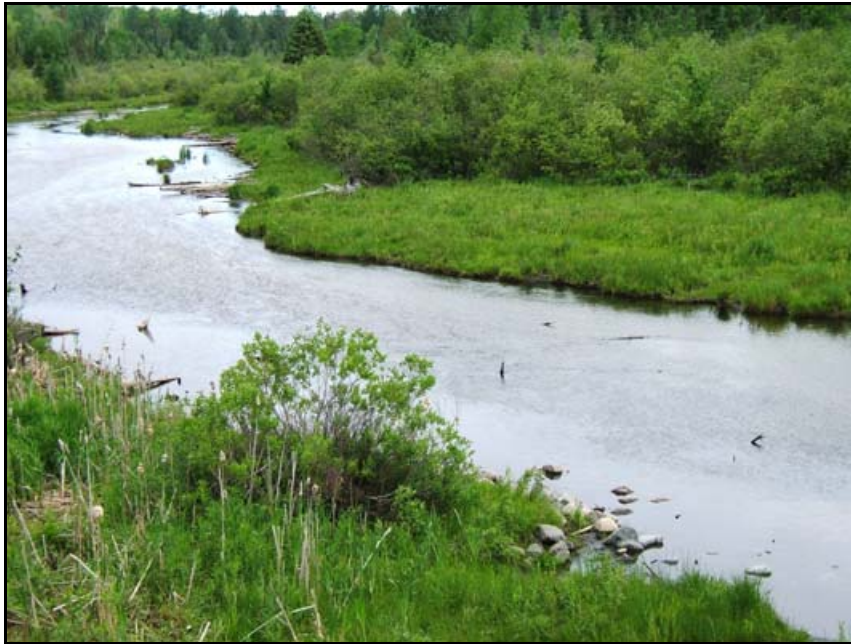
Photo 10. Iron River in area of old impoundment upstream of Wild River Road within the macroinvertebrate sampling reach.
(Looking upstream)

The Iron River just upstream of Wild River Road (the old impoundment area) is depicted in Photo 10. It was lacking in a number of habitat metrics including epifaunal substrate and pool substrate composition due to sediment deposition caused by the old dam structure. In spite of these habitat impairments, this site still had a habitat metric score of “Good” and a macroinvertebrate community rating of “acceptable” with a +2 score. We encountered 31 types of macroinvertebrates including large numbers of baetid mayflies, midges, physid snails, fingernail clams, water boatmen, scuds and worms. Many of the taxa collected were mainly associated with aquatic plant beds, areas of woody debris and fine sediment common to this site.

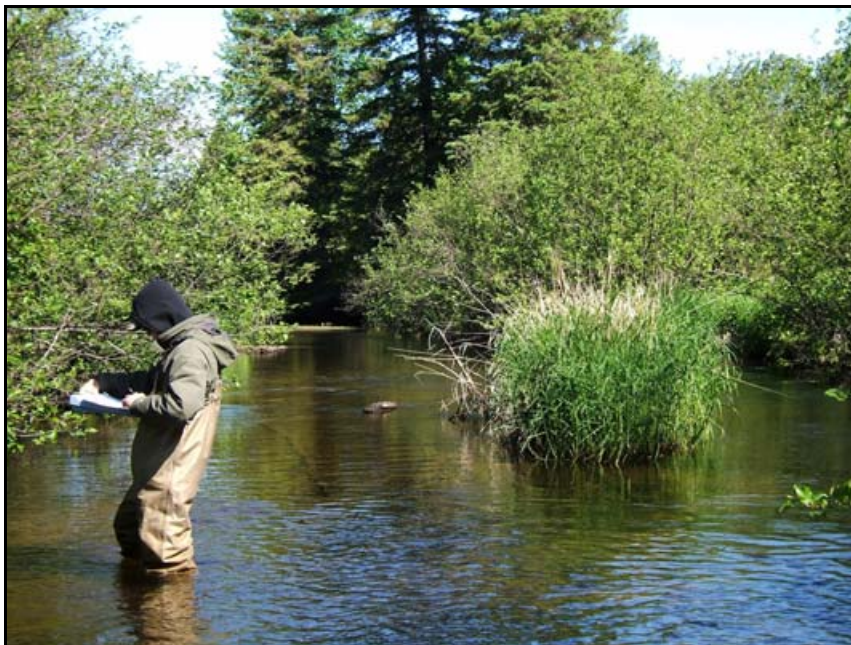
The Iron River downstream of Wild River Road (coinciding with the upstream portion of Reach 15) is depicted in Photo 11. It showed improvements in the in-stream habitat with an overall rating of “Excellent.” This stream segment had improved habitat metric scores in 10 of 14 categories (Table 12) compared to sampling station in the old impounded area. The macroinvertebrate community remained similar in total number of taxa, but increased numbers of mayfly and caddisfly families were present thus increasing the total overall macroinvertebrate score to a +3 (“Acceptable”). The most common macroinvertebrate taxa encountered were scuds, baetid mayflies, midges, and hydropsychid and brachycentrid caddisflies.

Photo 11. Iron River about seventy-five meters downstream of Wild River Road within the macroinvertebrate sampling reach.
(Looking downstream)

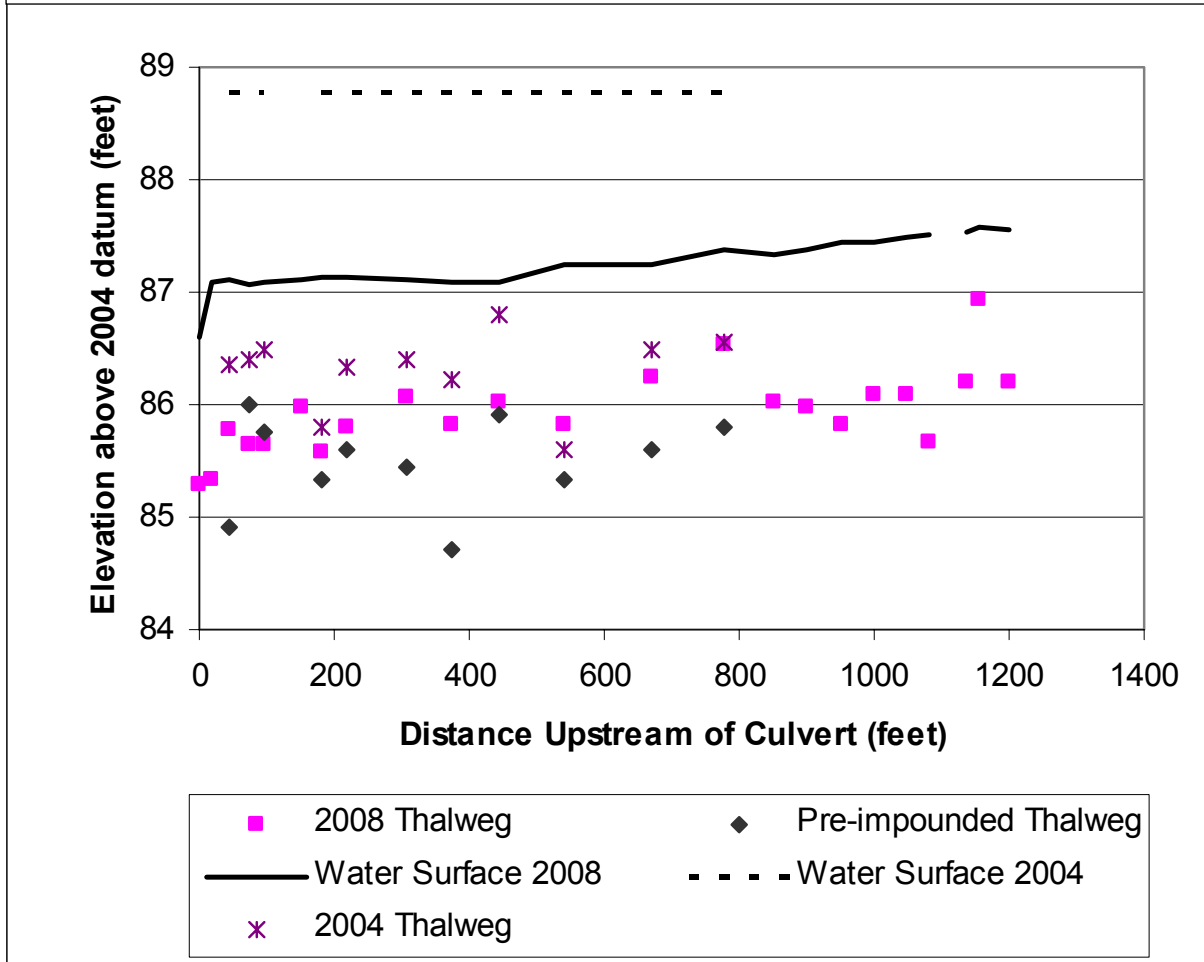
Figure 2. Longitudinal profile of water surface and thalweg before and after removal of the dam

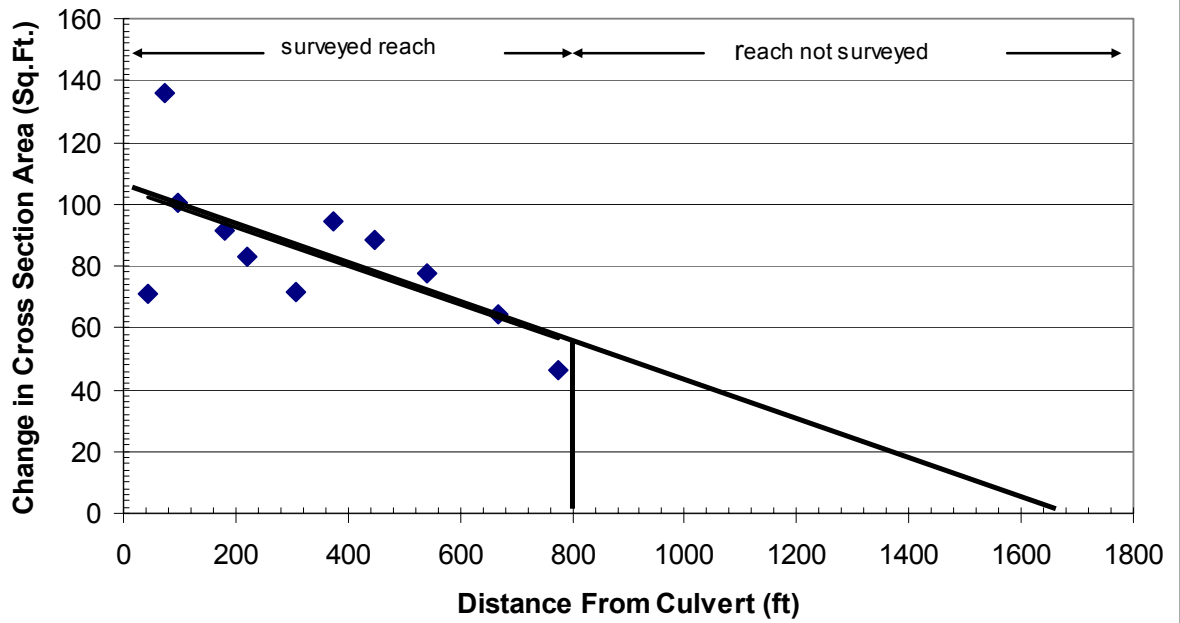
Figure 3. Change in Cross Sectional Area of the Transect Between 2004 and 2008

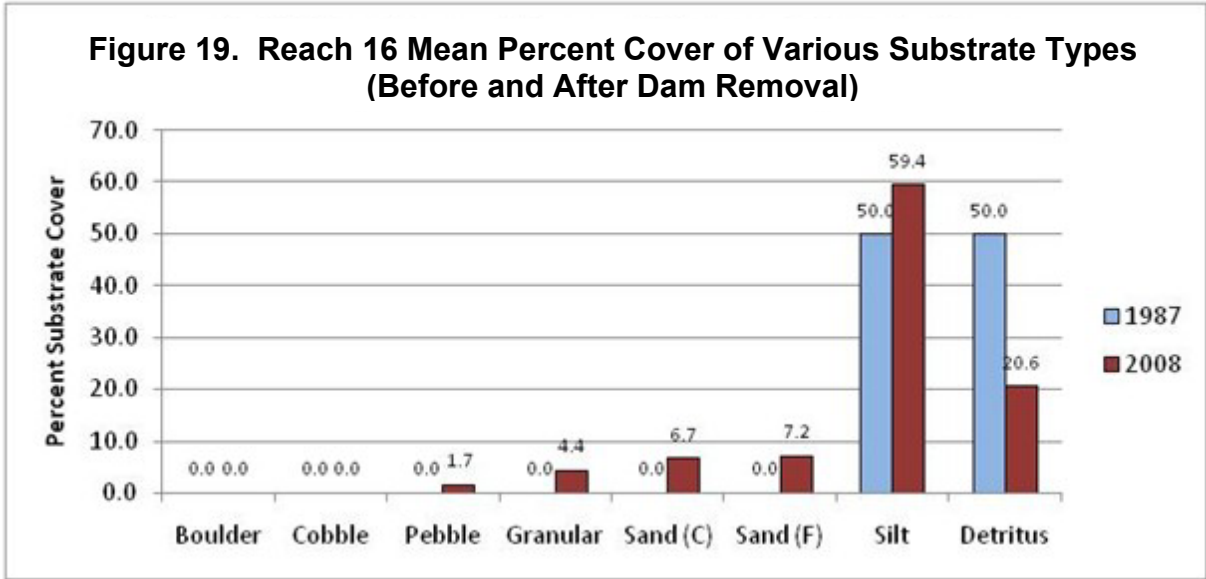
Note: Substrate types include: boulder (>256 mm), cobble (256 to 64 mm), pebble (64 to 4 mm), granular (4 to 2 mm), sand-coarse (2 to 0.25mm), sand-fine (0.25 to 0.062 mm), silt (0.062 to 0.004 mm), and detritus (organic material of various sizes).

Note: In 1987, substrate was not estimated on each 50 meter transect of Reach 16 as it was impounded at the time. The substrate was simply classified as "mud." For comparison purposes in Figure 18, "mud" was designated as 50% coverage by silt and 50% coverage by detritus.

A summary of percent cover of the eight substrate types (boulder, cobble, pebble, granular, coarse sand, fine sand, silt, and detritus) are presented in Figures 18, 19, and 20. In Reach 15, the coarser stream substrate categories did not show dramatic change before and after dam removal. At the finer end of the scale, there was a large decrease in fine sand, but a corresponding increase in silt. Both are fine materials and probably represent similar (poor) habitat characteristics with regard to aquatic macroinvertebrates and fish. Detritus was not observed by the 1987 study but was present in 2008 as over 10% of the substrate cover. It is possible that silt and detritus increase noted in 2008 was released from the removal of the wood dam. It is also possible that the 1987 study was measuring a dynamic period in the streambed since just a decade earlier (1976) a larger and older dam was removed thus releasing materials to the downstream area of Reach 15.

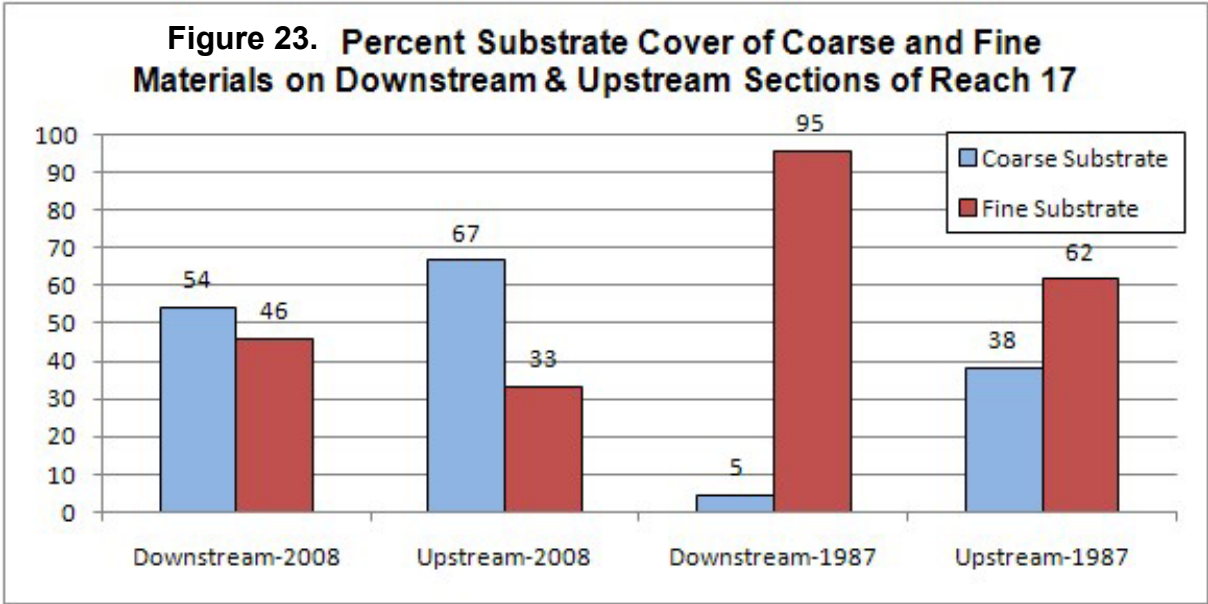
Note: **Coarse Substrate** includes the combination of: boulder (>256 mm), cobble (256 to 64 mm), pebble (64 to 4 mm), granular (4 to 2 mm)
Fine Substrate includes the combination of: sand-coarse (2 to 0.25mm), sand-fine (0.25 to 0.062 mm), silt (0.062 to 0.004 mm), and detritus (organic material of various sizes).

Note: Downstream Section of Reach 17 includes 250 m through 750 m transects.
 Upstream Section of Reach 17 includes 800 m through 1350 meter transects.
