# Iron River – Iron County, Michigan

## Channel Assessment Report

December 26<sup>th</sup>, 2011

Andy Selle, P.E.  
Inter-Fluve Inc  
3602 Atwood Ave  
Madison, WI

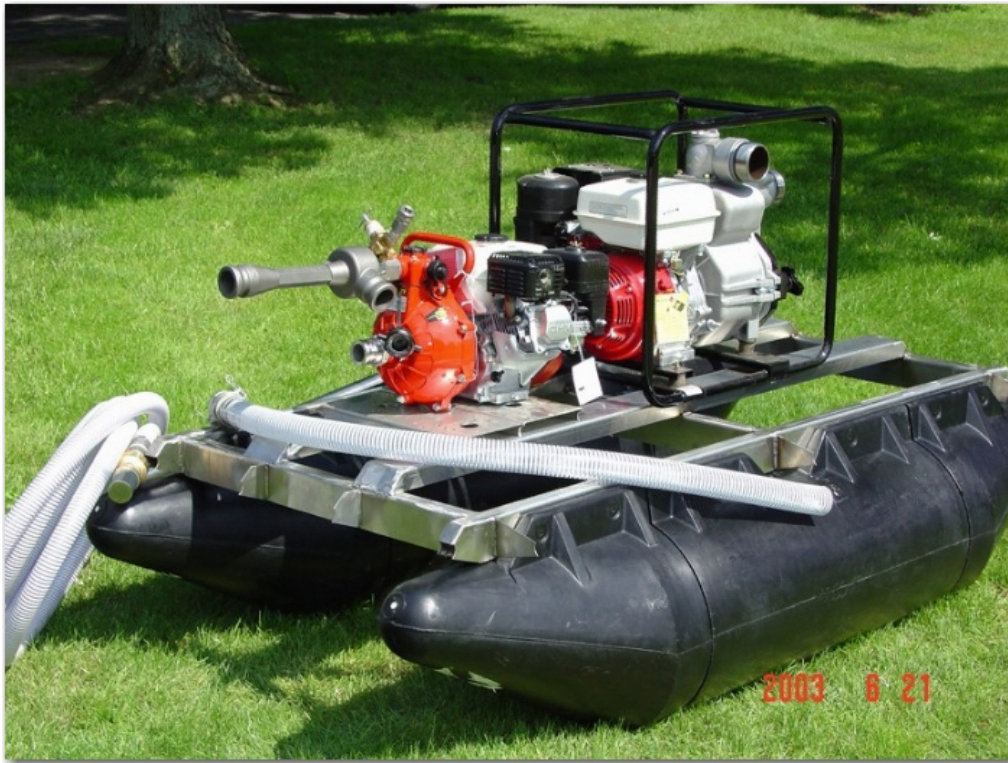
**Figure 13:** A portable hydraulic dredge may be necessary to remove accumulated sand from the channel.

As mentioned, the river appears to have natural processes in place for recovery once the hydraulic controls are removed, but the expected form of recovery and the potential for the river to reach this on its own should be understood. If the channel is in fact highly manipulated from relic logging era structures, more aggressive techniques of sediment removal and restoration may need to be employed ahead of the use of large wood and other measures. This effort could require significant resources if deemed appropriate and should be considered carefully. Typical approaches have been the use of small mobile dredges that can remove material and deposit it in overbank areas. A photo of such a device is below.

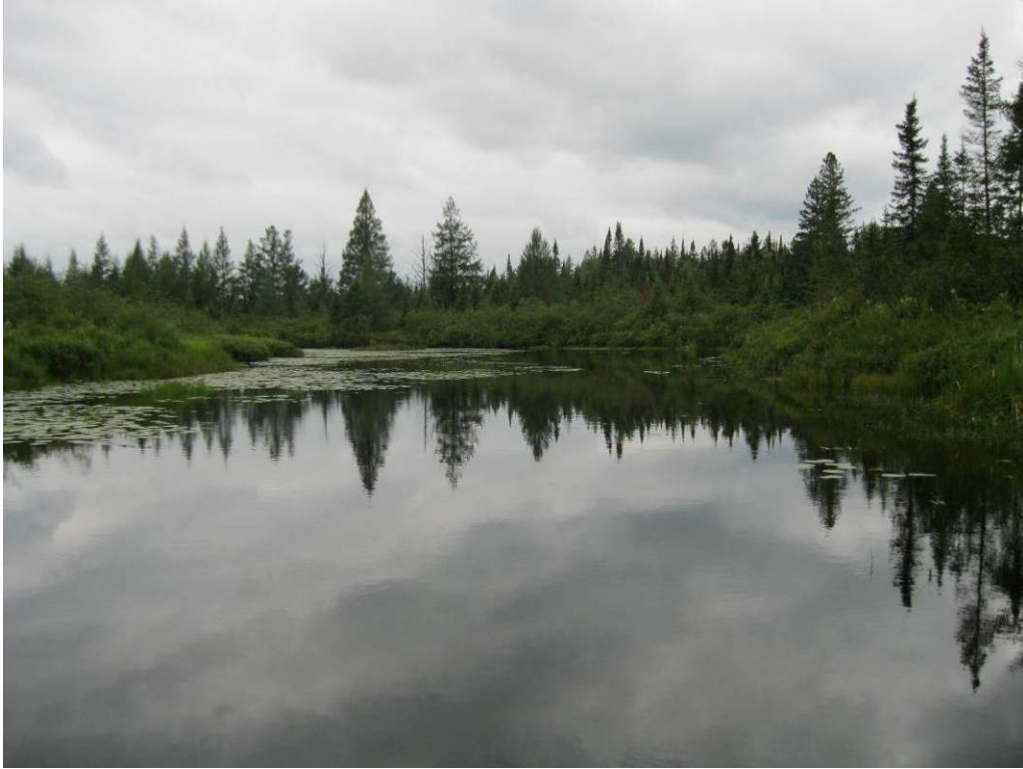
**Figure 15:** Station 108,000. Typical wide section of river characteristic of the flat bed slope sections of the stream.

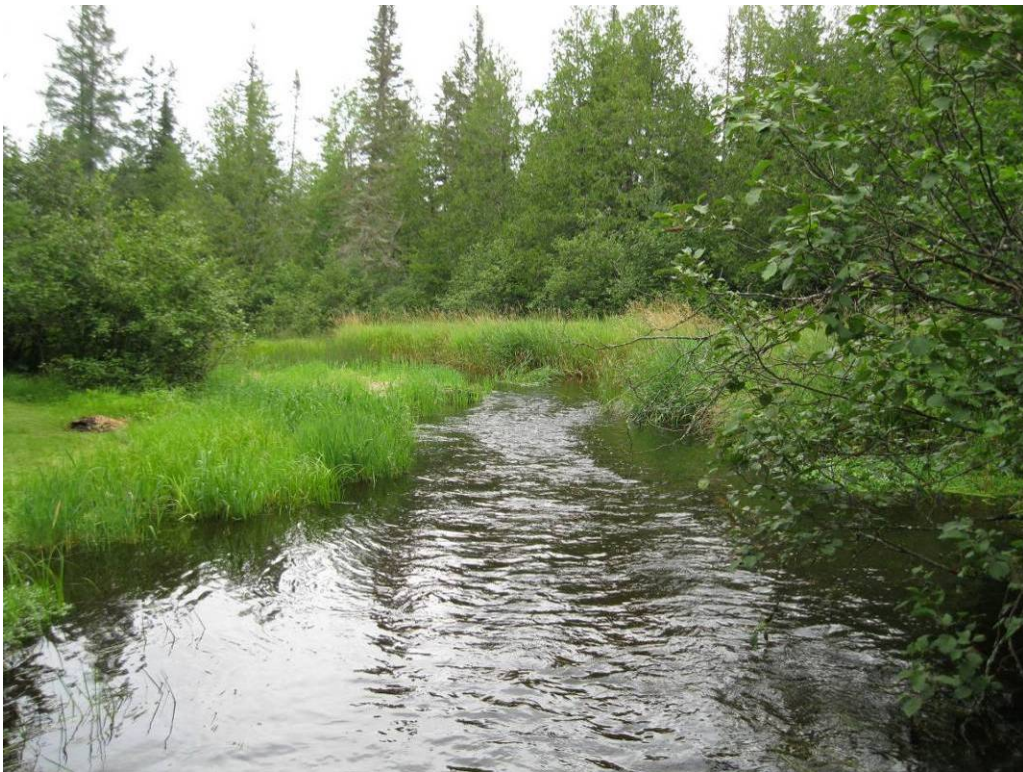
**Figure 16:** Station 102,000. Example of higher gradient transition section between flat sections in the upper segment. Note the mature trees close to the stream and the narrow channel as the stream enters this section

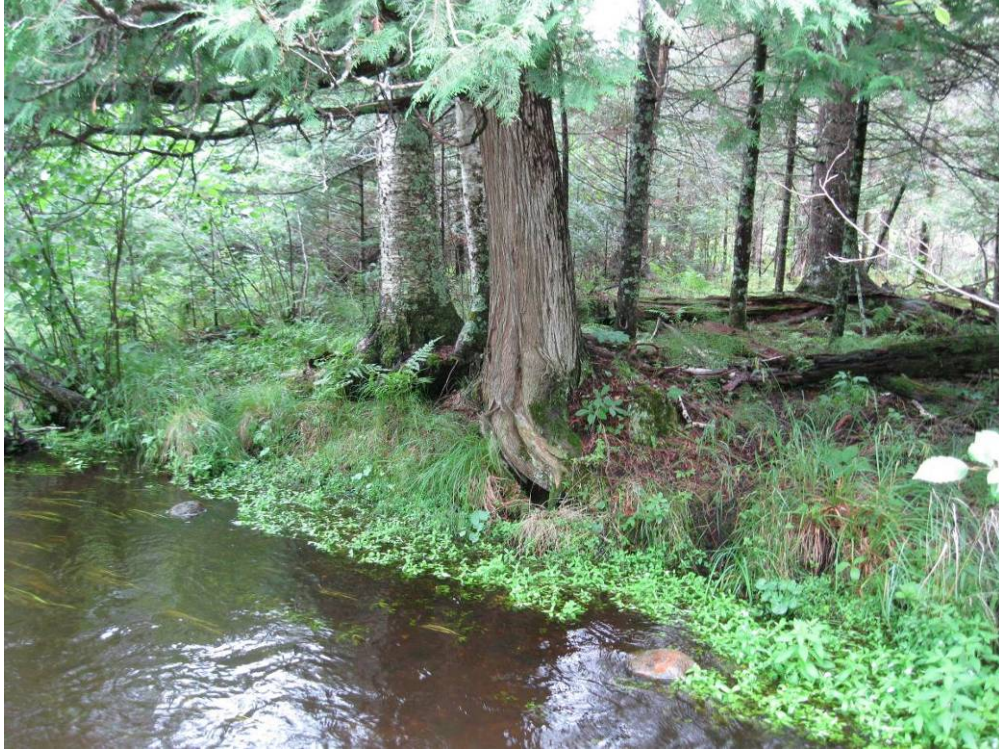
**Figure 17:** Example of steep section of stream at station 101,800. Second, perhaps third growth forest abuts the channel edge. Eventually these trees will die and fall into the river inducing scour pools and fish habitat. Note vegetation growing in the channel, indicating high stability.

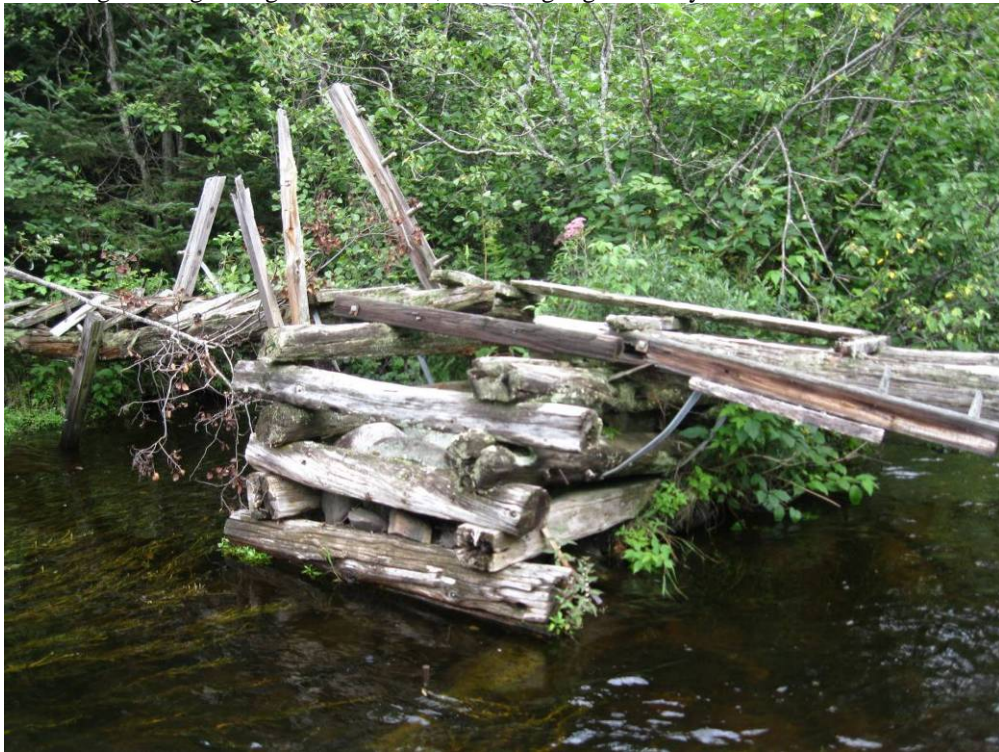
**Figure 18:** Relic bridge crossing for the Christiansen Trail, located at station 96,500. This historic nature of this feature is unknown.

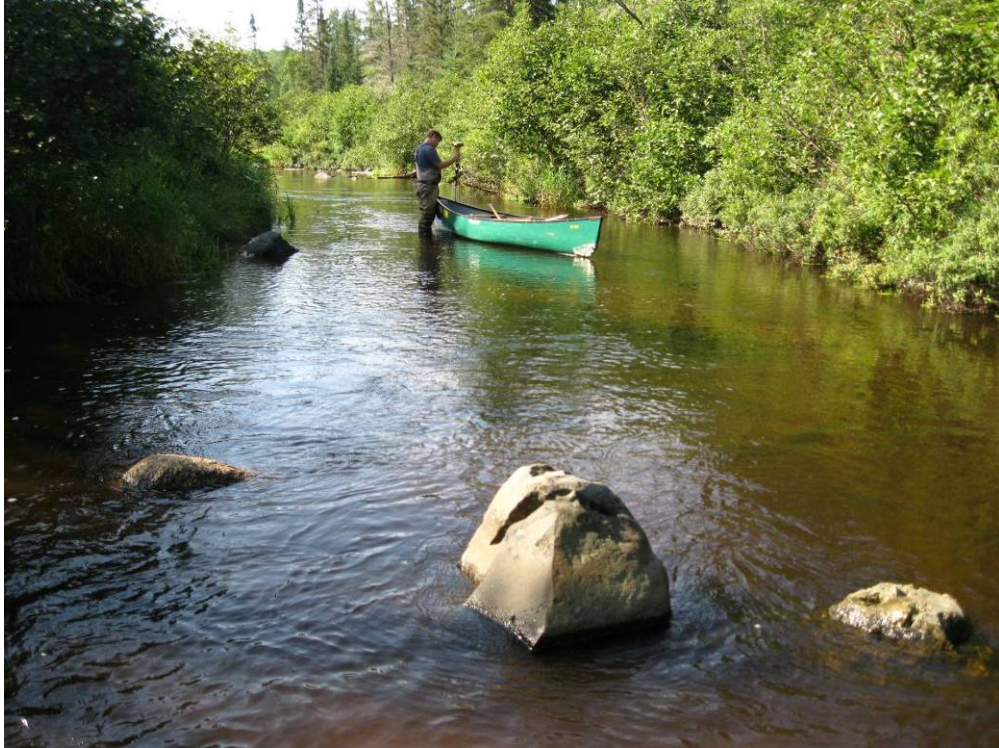
**Figure 19:** Boulders in the river bed at station 93,700 indicate some geologic control. The river does not have the power to move these boulders. They are exposed (not covered by fines) and thus the bed elevation at this location is likely an original bed elevation.

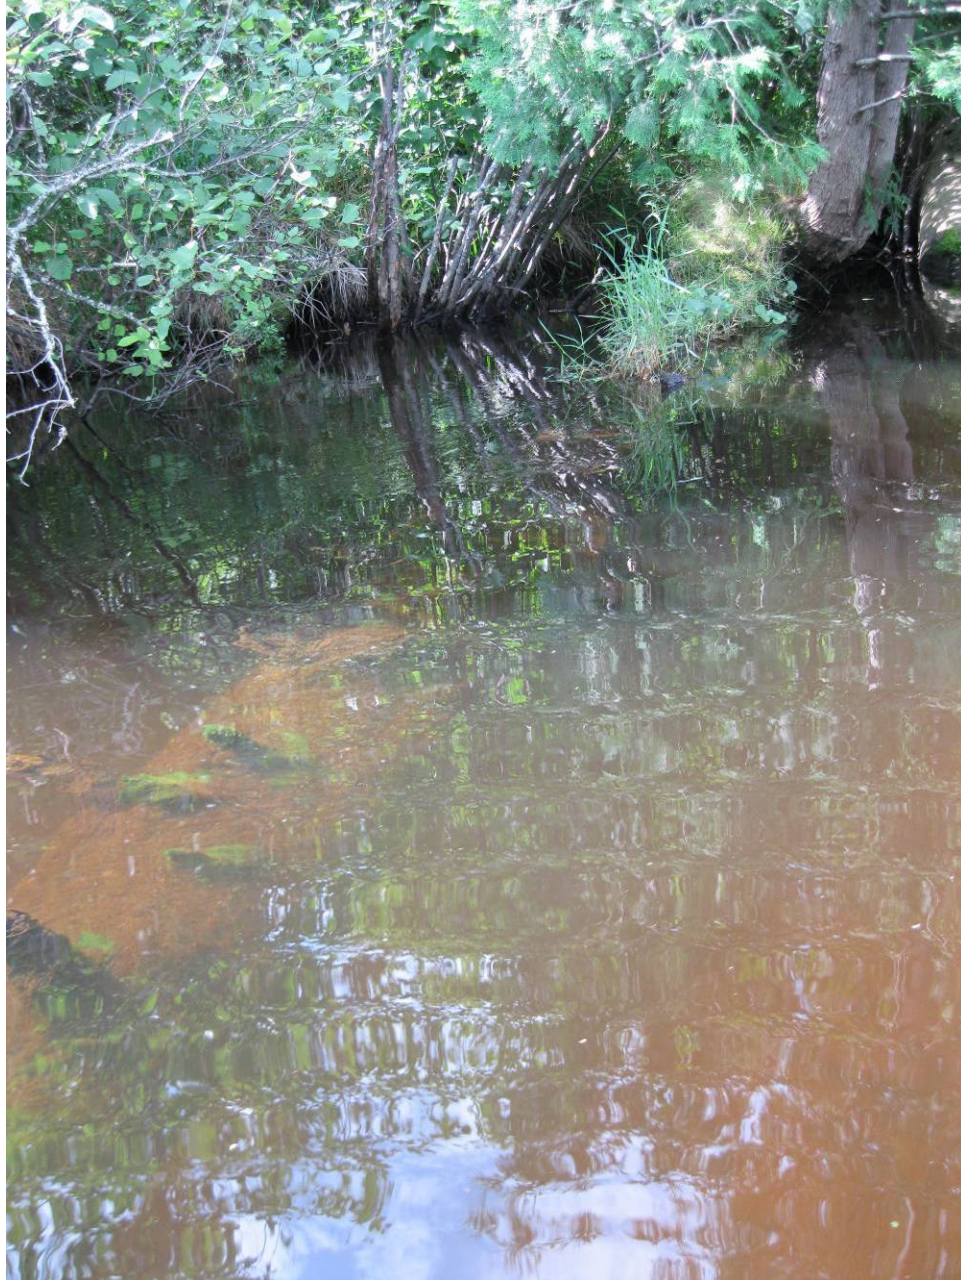
**Figure 21:** Excellent example of large wood habitat in the river (station 89,900), note the submerged log, deep scour pool, and undercut bank. This habitat is lacking throughout the river.

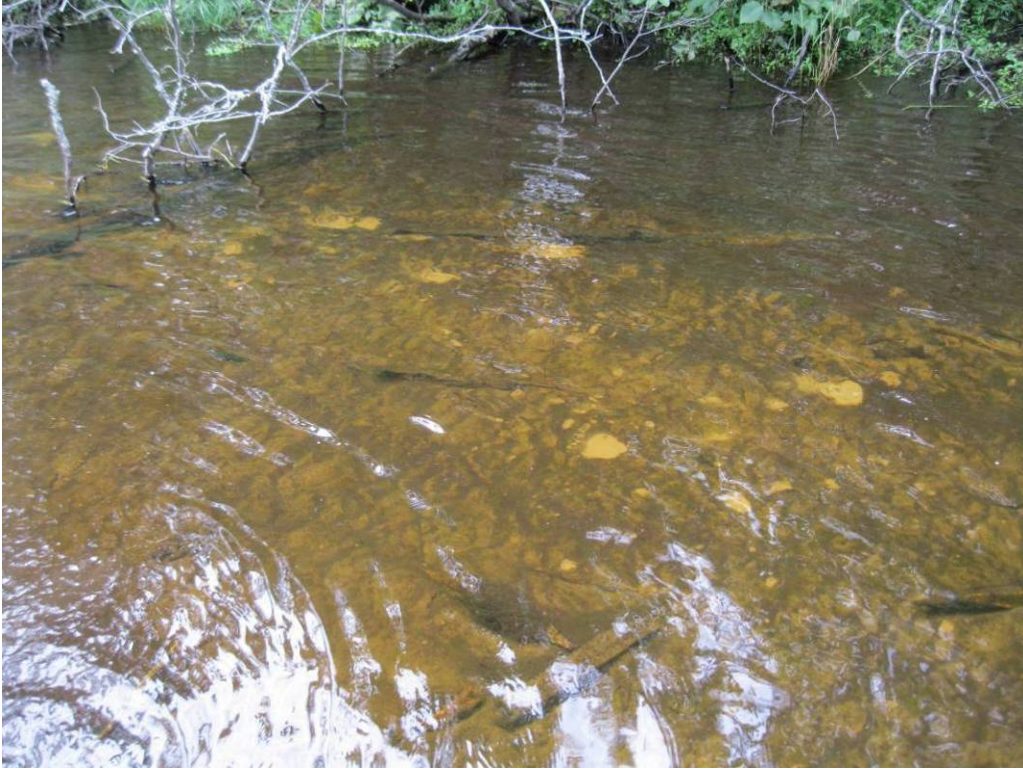
**Figure 22:** Groundwater upwelling in the river bed at station 89,300, noted by the circles of clean sand. These areas are important to Brook Trout spawning, and may be mapped using a thermometer probed in the bed along the entire profile of the Upper Segment.

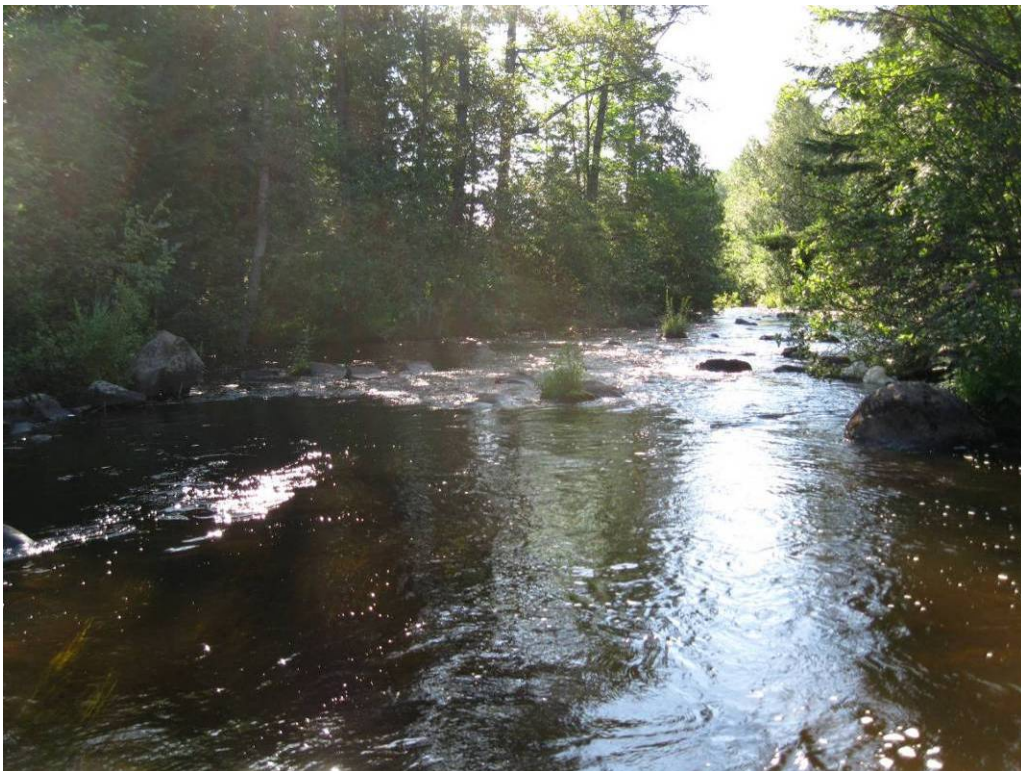
The steep section immediately below Gibbs City Rd is one of the best examples of pool riffle habitat on the river. Large boulders occupy the stream, clean gravels compose the bed for about 1000'. At station 83,300, a large amount of wood is present in the stream, along with a large amount of fines. The valley wall comes very close to the river channel here and it appears this may have been a log staging area along the bank. Given the location of the Burnt dam, an old logging dam located a few thousand feet downstream, this may have been a logical use. The habitat here, even with the relic wood, is poor and the river nearly doubles in width. This section is short however, and soon after the river returns to a steep boulder cascade consistent with the character seen upstream. At station 82,200, the channel changes abruptly to a lower gradient stretch. The boulders are gone and a blanket

**Figure 25:** Section immediately below Gibbs City Rd, one of the best examples of steep gradient, riffle pool sequences on the river. Preservation of this reach should be a priority.

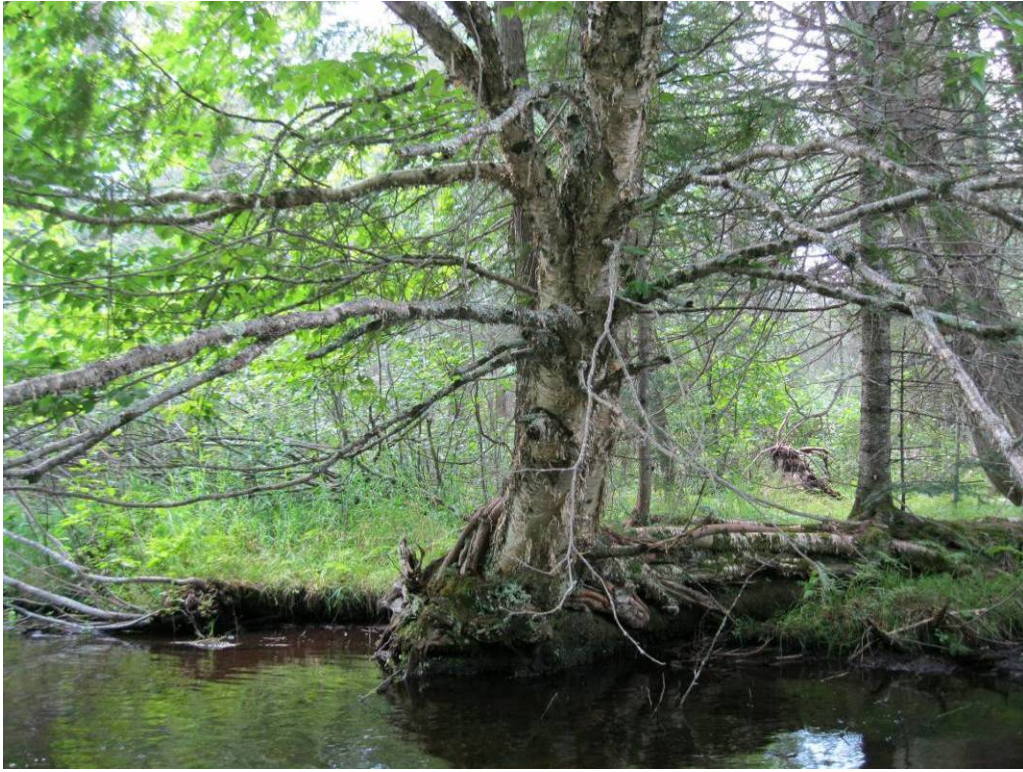
**Figure 28:** Old birch tree located on the bank of the river near station 77,200. This is an obvious sign of stability at this location of the river.

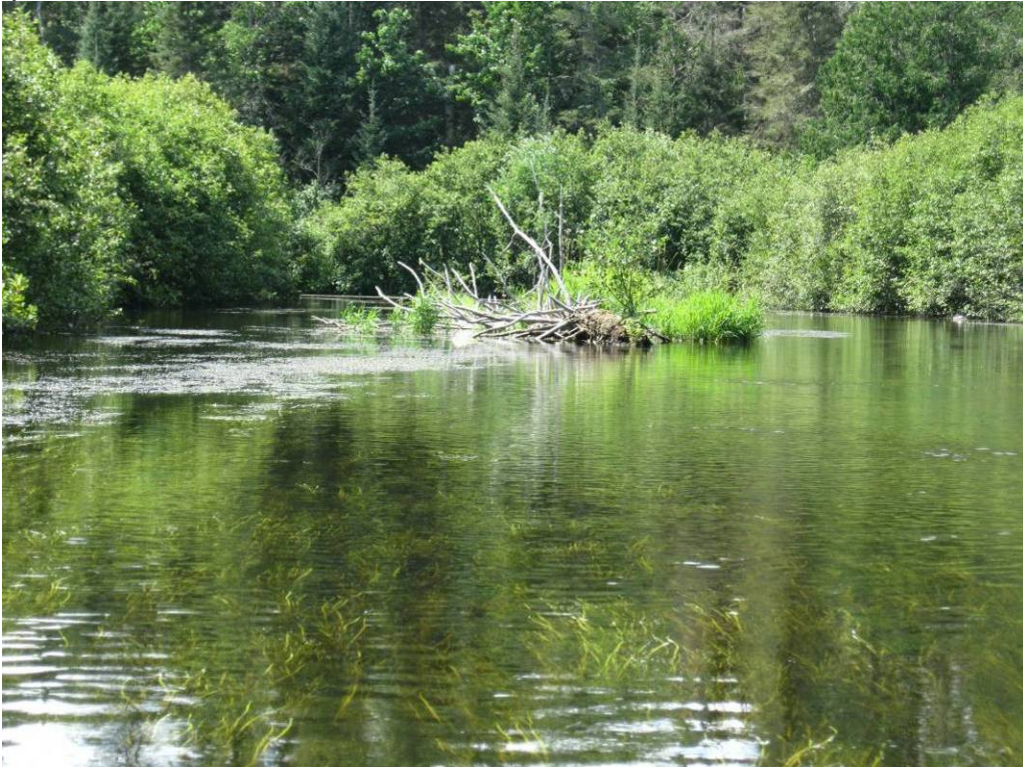
**Figure 29:** Mid-channel bar, formed at station 74,900. The bed is composed of fine well vegetated sand. The channel widens considerably here and may be a natural feature or perhaps the result of some historic manipulation.

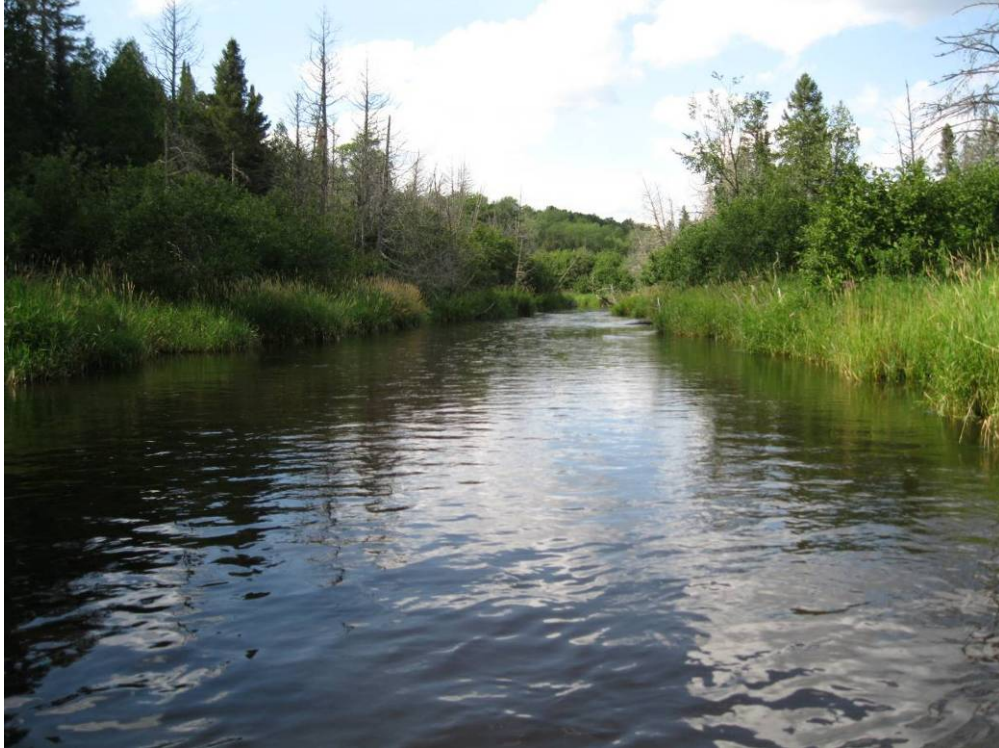
**Figure 30:** Example of long run section around station 66,400. Note the dead trees along the riparian area that will provide wood habitat. The bed in this section is largely composed of coarse materials, though fines are deposited along the margins. The addition of large wood habitat in this reach would increase habitat complexity considerably.

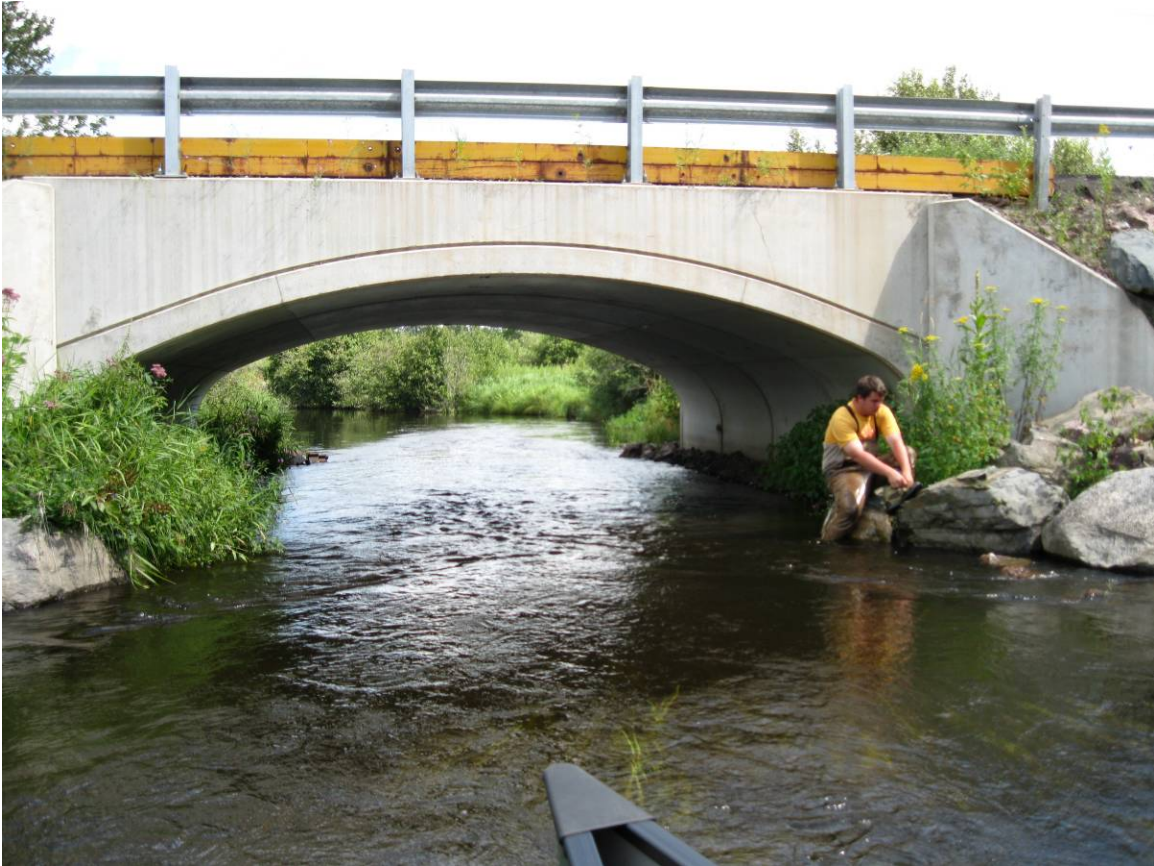
**Figure 32:** The Mottes Rd culvert, a great example of a bottomless road crossing that does not act as a bed control on the stream slope and passes aquatic species easily. This crossing does cause a flow constriction and ideally should have been sized for slightly wider than a bankfull width, but the impact is minor.

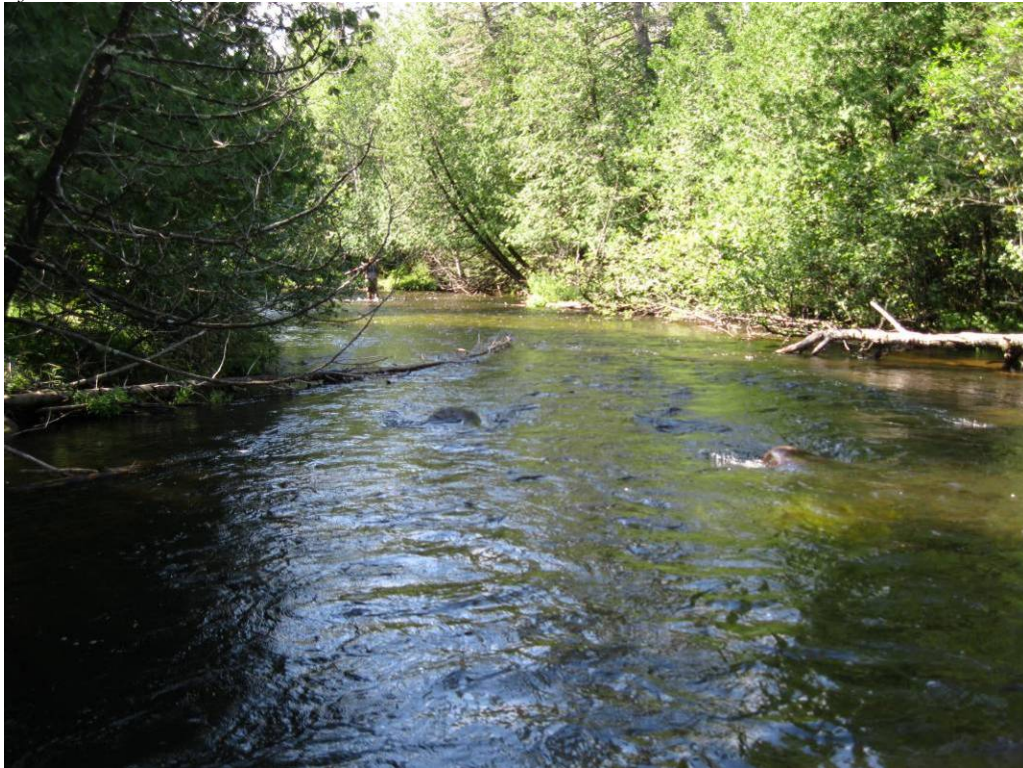
**Figure 33:** Typical view of some excellent habitat located below Mottes Rd.

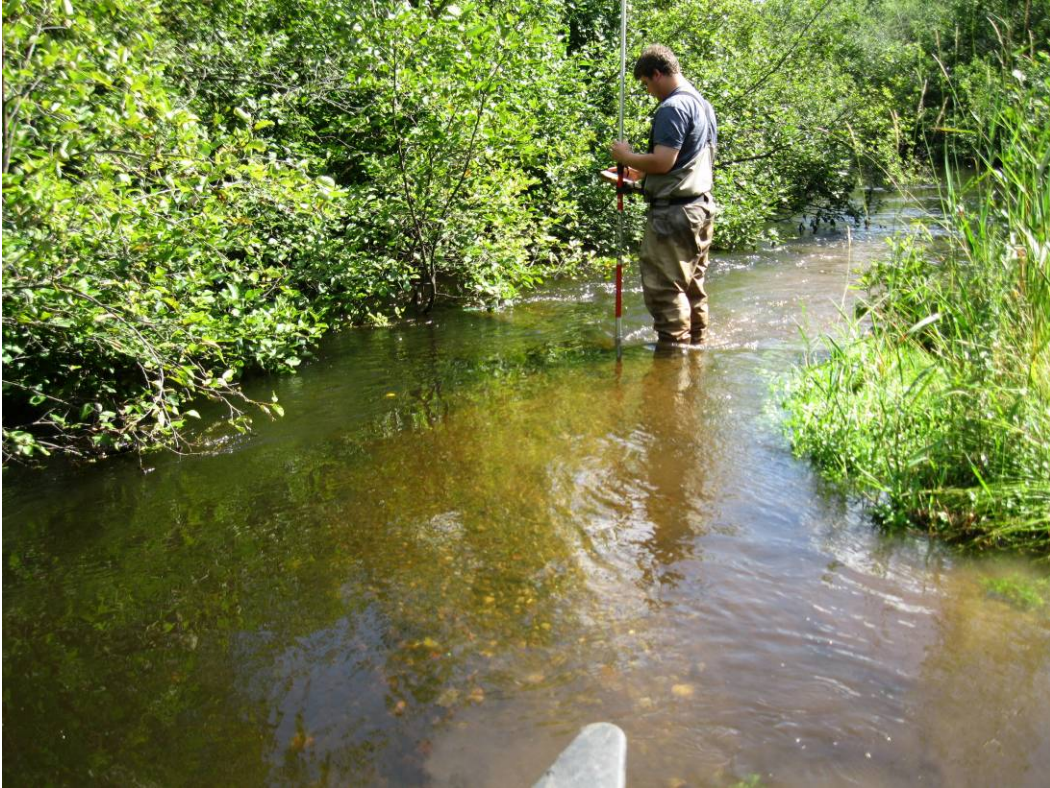
**Figure 34:** Photo of tributary contributing sand and gravel to the Iron River at station 54,400.

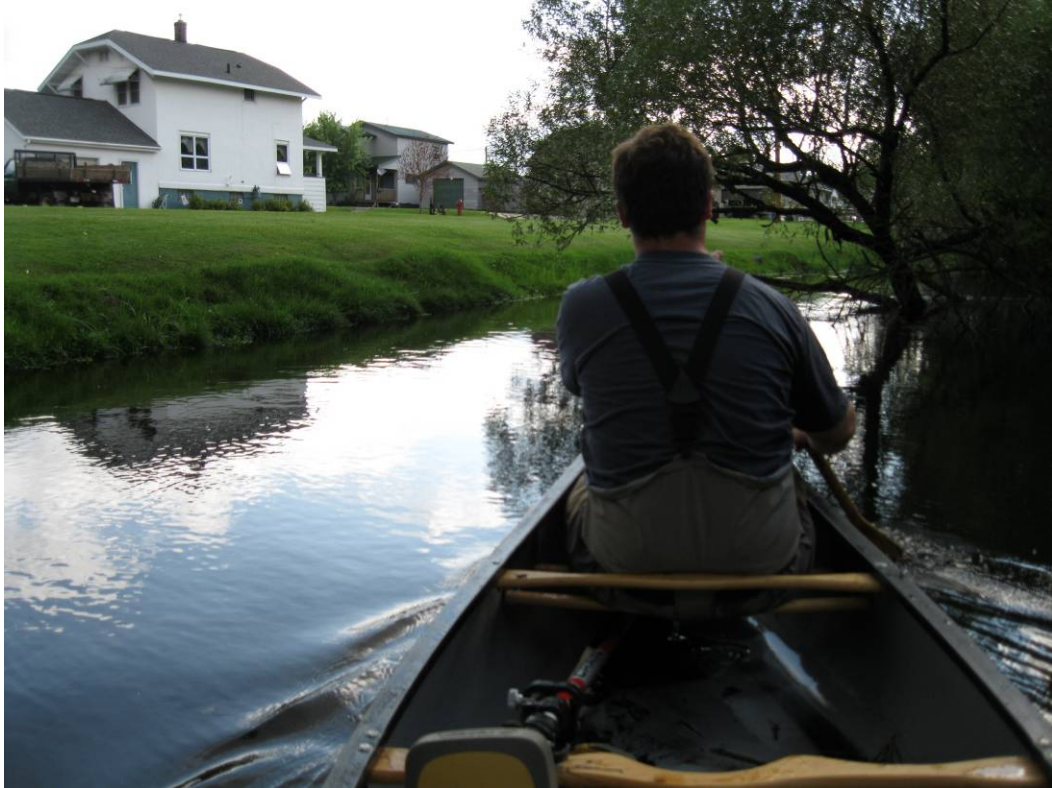
**Figure 36:** Station 50,300, the riparian zone begins to be influenced by residences within Iron River

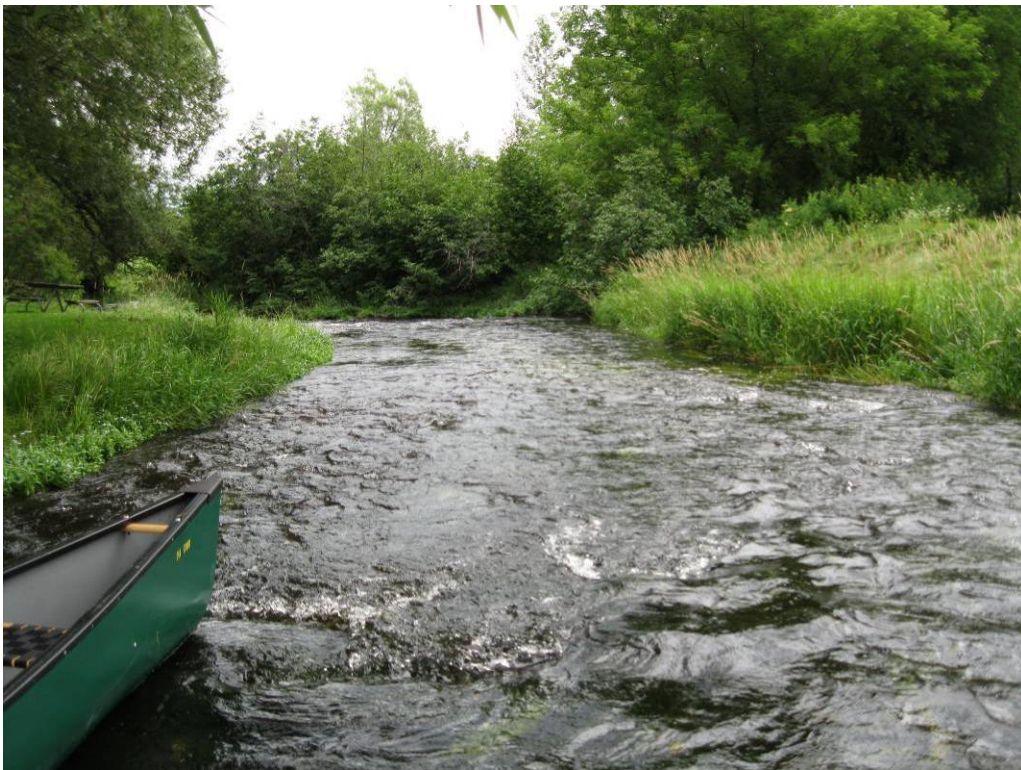
**Figure 39:** Steep section below 4th Ave. This is one of the steepest sections on the river at 1%, but only lasts through the park before the slope becomes mild.

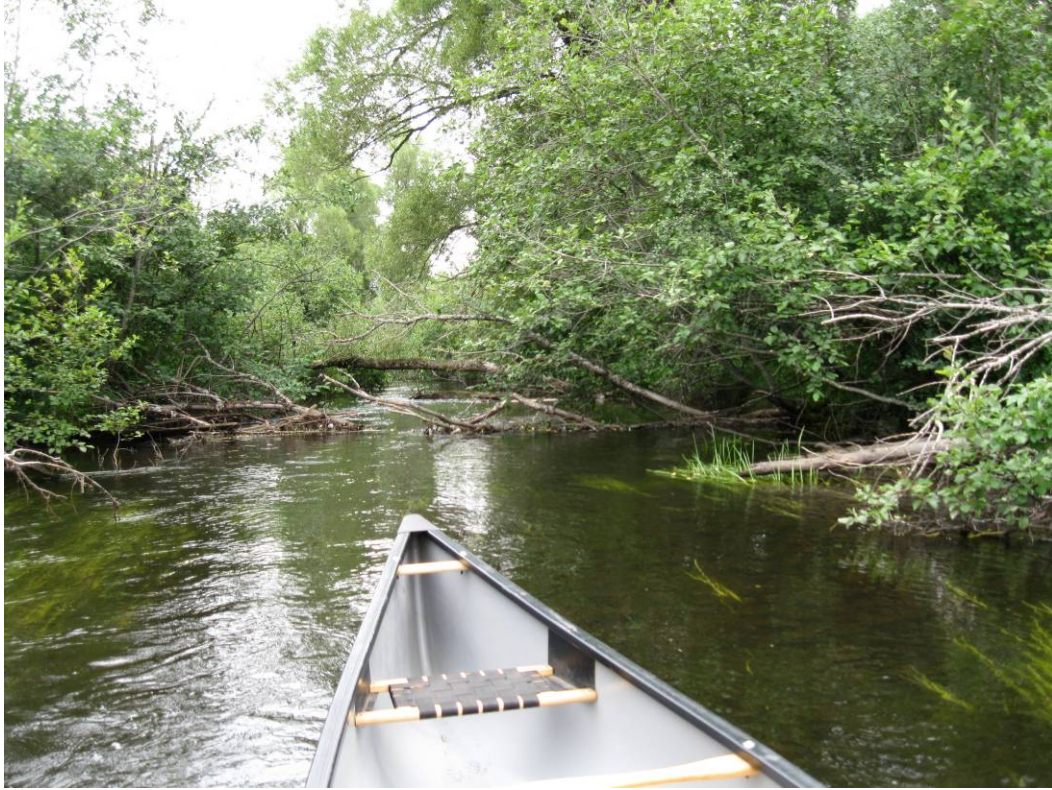
**Figure 40:** Typical view of habitat around station 47,000. This reach through town has wood in the channel, a coarse bed and good habitat for an urban channel

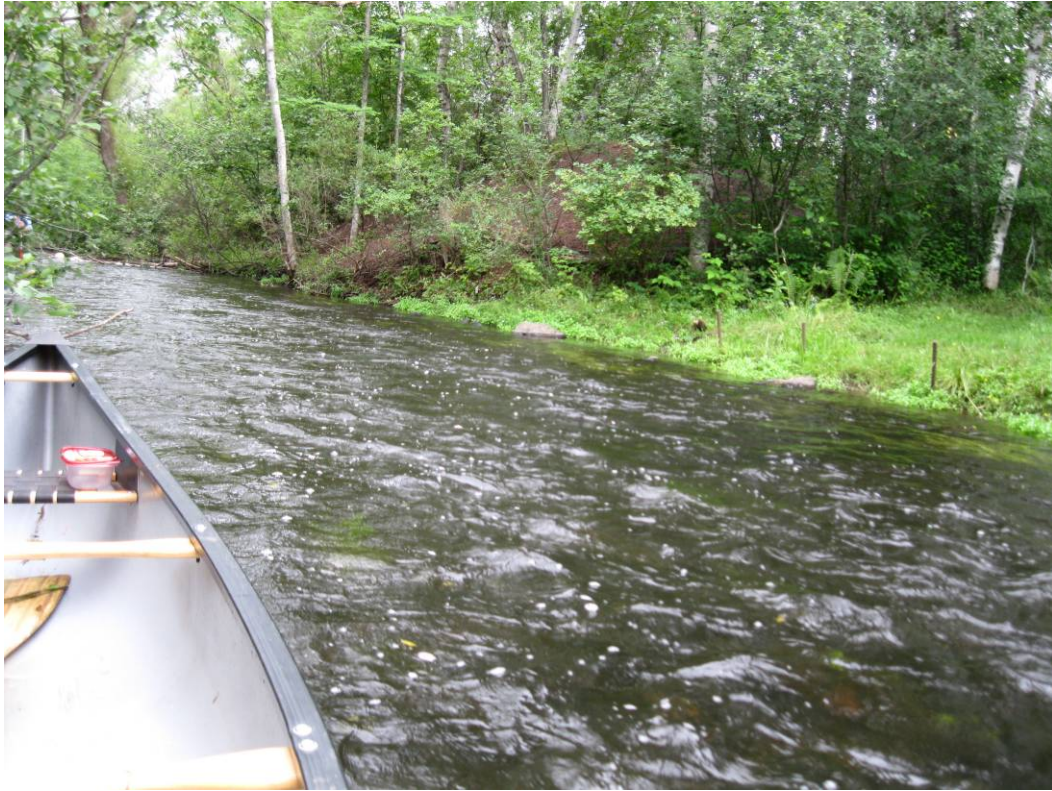
**Figure 42:** Habitat through town is consistently good. Here low banks provide easy access to the floodplain and the river moves across coarse sediments with relatively little embedded fines

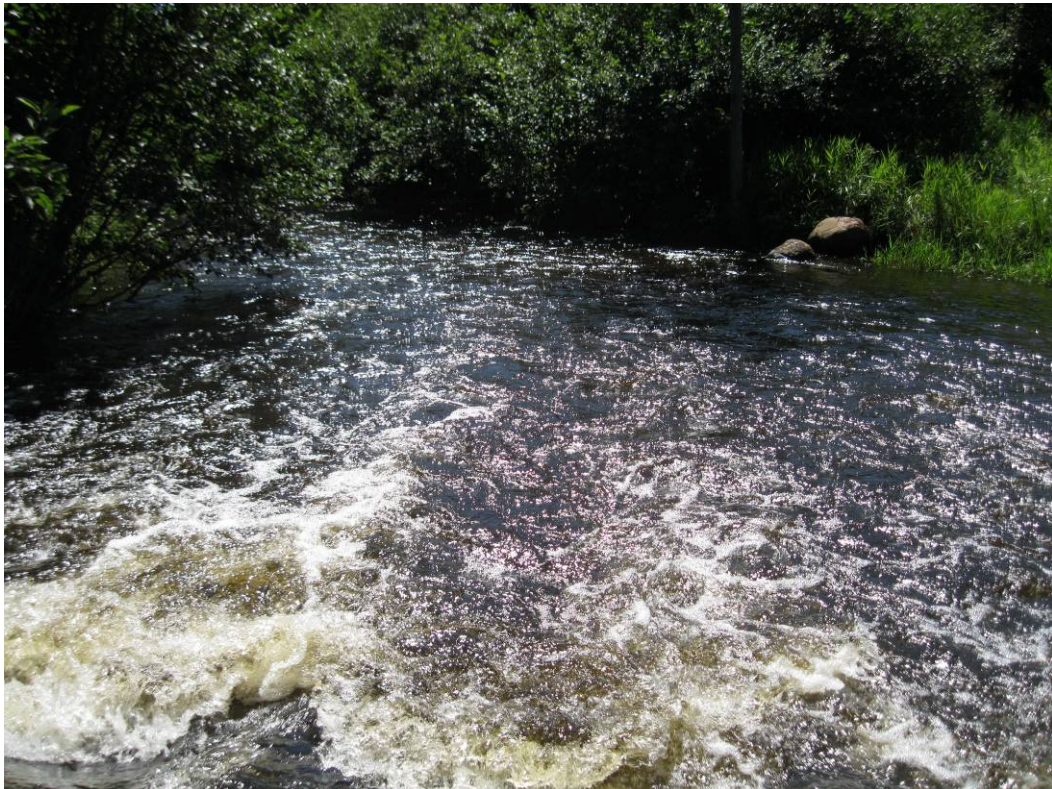
**Figure 50:** Long riffle at station 32,100. The riffle extends to station 31,450

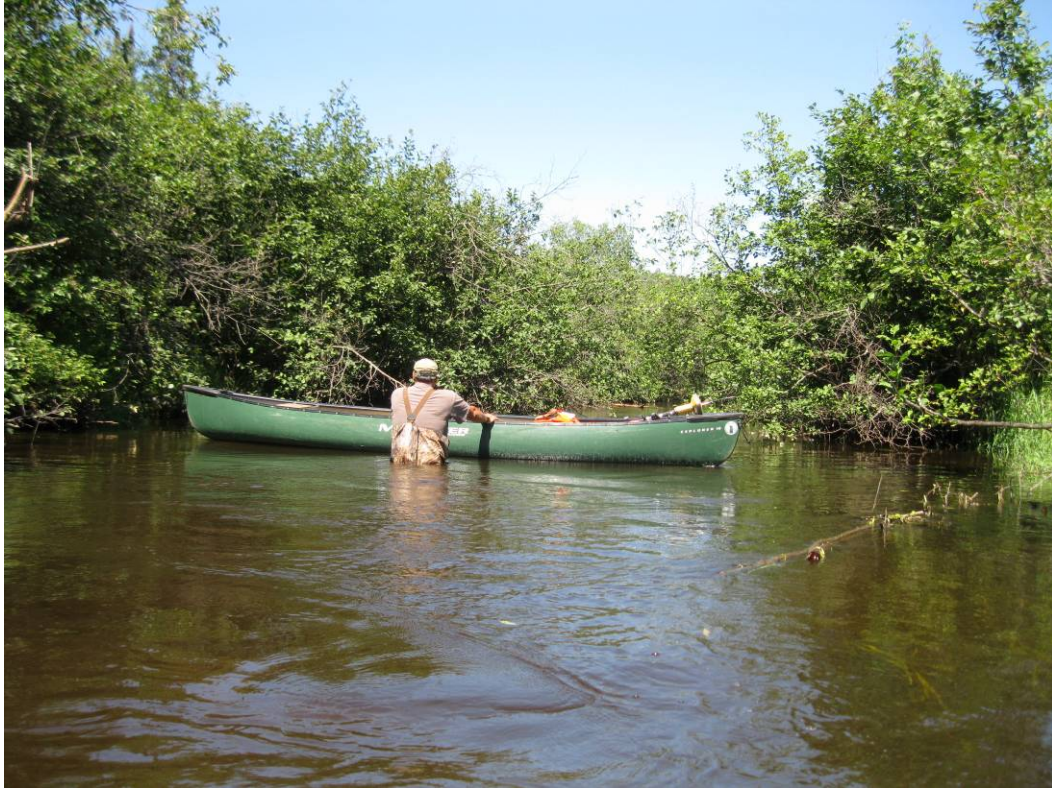
**Figure 51:** Wide section at station 27,700, still good habitat and depth
